# Access Compliance Report

## Public Rights-of-Way

### (Curb Ramps)

Intersection ID: 30383	Main Street: BELLSOUTH_DR	Cross Street: CENTRAL_AV	Location: E
ADA ID: D74386E32FE2	Ramp Type: Perp	Initial Pass/Fail: Fail	Overall Compliance: No
Severity Score: 12.5			
Codes/Mitigation Info/Possible Solution		Field Measurements/Component Compliance

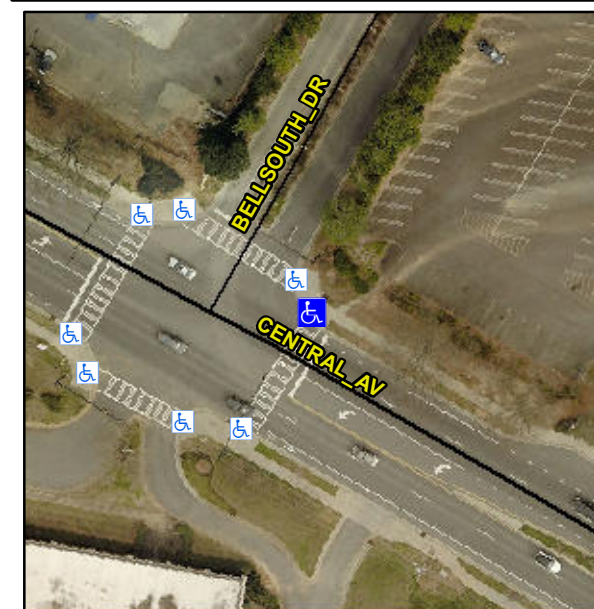
**Not Found, R304.2.2**

Compliance	Description	Data	Compliance	Description	Data
N/A	Ramp Length (in)	60.5	No	Ramp Slope (%)	8.5
Yes	Ramp Width (in)	48.0	Yes	Ramp XSlope (%)	1.0
N/A	Flare Type LT	N/A	N/A	Flare Type RT	N/A
N/A	Flare Slope LT (%)	N/A	N/A	Flare Slope RT (%)	N/A
N/A	Flare Traversable LT?	N/A	N/A	Flare Traversable RT?	N/A
N/A	Landing Length (in)	N/A	N/A	DWS Provided?	N/A
N/A	Landing Width (in)	N/A	N/A	DWS Contrast?	N/A
N/A	Landing Slope (%)	N/A	N/A	DWS Length (in)	N/A
N/A	Landing X Slope (%)	N/A	N/A	DWS Full Width?	N/A
N/A	Landing Curb? (Y/N)	N/A	N/A	DWS Offset (in)	N/A
N/A	Shared Landing?	N/A			
N/A	Gutter Ponding?	N/A	N/A	Gutter Slope (%)	N/A
N/A	Gutter Lip Ht (in)	N/A	N/A	Gutter X Slope (%)	N/A
N/A	Painted X Walk1?	Yes	N/A	Painted X Walk2?	N/A
	X Walk 1 Direction	To SW		X Walk 2 Direction	N/A
N/A	X Walk 1 Width (in)	111.0	N/A	X Walk 2 Width (in)	N/A
	X Walk 1 Slope (%)	3.1		X Walk 2 Slope (%)	N/A
	X Walk 1 X Slope (%)	2.6		X Walk 2 X Slope (%)	N/A

N/A	Ramp inside XWalk1?	Yes	N/A	Ramp inside XWalk2?	N/A
	Road Slope (%)	N/A	N/A	Clear Space?	N/A
	Road X Slope (%)	N/A	N/A	Clear Space to XWalk (in)	N/A
N/A	Any Obstructions?	N/A	N/A	Storm Grate/Utility Hazard?	N/A
	Obstruction Type			Storm Grate/Utility Type	
		N/A			N/A
			Yes	Surface Condition? (G/P)	Good

**Remove & Replace Entire Ramp.**

Total Cost: \$ 1850.00
