# Access Compliance Report

## Public Rights-of-Way

### (Curb Ramps)

| Intersection ID: 49273 | Main Street: REMINISCE_LN | Cross Street: REUNION_ST | Location: SE |

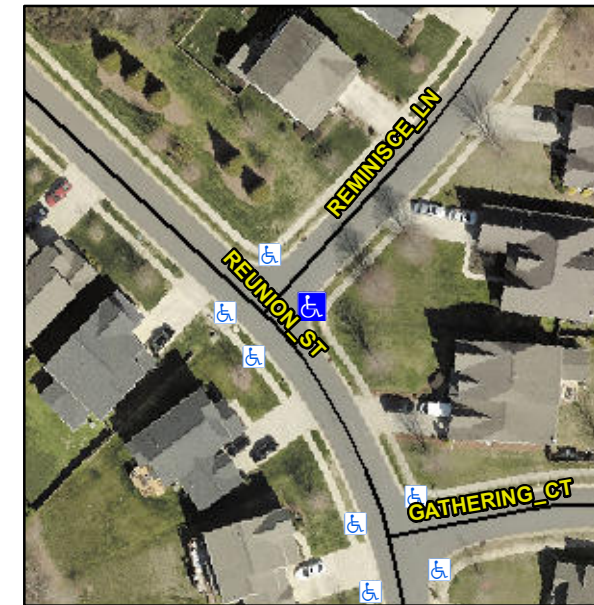
| ADA ID: D74655DE3BFB | Ramp Type: PerpDiag | Initial Pass/Fail: Pass | Overall Compliance: No |

**Not Found, R304.2.1, R304.2.2-Perp, R304.3.2-Para**

| Compliance | Description | Data | Compliance | Description | Data |
|---|---|---|---|---|---|
| No | Landing Length (in) | 47.0 | Yes | DWS Provided? | Yes |
| No | Landing Slope (%) | 3.3 | Yes | DWS Length (in) | 24.5 |

**Remove & Replace Curb Ramp With Two New Directional Ramps or Equivalent.**

Total Cost: \$ 3200.00
