# Access Compliance Report

## Public Rights-of-Way

### (Curb Ramps)

Intersection ID: 7050	Main Street: CARRINGTON_DR	Cross Street: TILDEN_RD	Location:	W
ADA ID: D74A6EA67198	Ramp Type: Perp	Initial Pass/Fail: Fail	Overall Compliance: No	Severity Score: 25

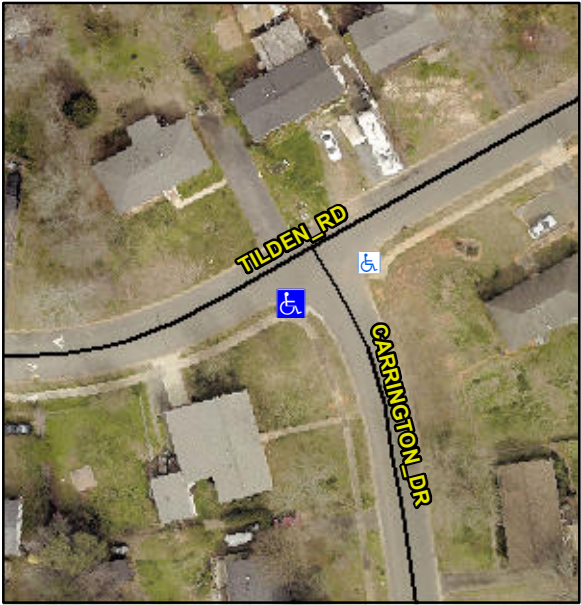
Possible Solutions:		<b>Compliance</b>	<b>Description</b>	<b>Data</b>
	Remove & Replace Entire Ramp.		N/A	Ramp Length (in)	47.0
			Yes	Ramp Width (in)	49.0
			N/A	Flare Type LT	N/A
			N/A	Flare Slope LT (%)	N/A
			N/A	Flare Traversable LT?	N/A
			N/A	Landing Length (in)	N/A
			N/A	Landing Width (in)	N/A
			N/A	Landing Slope (%)	N/A
			N/A	Landing X Slope (%)	N/A
<p>Surveyor Notes:</p> <p>N/A</p> <p>PROW/ADA:</p> <p>R304.2.2, R304.5.3</p>			N/A	Flare Type RT	N/A
			N/A	Flare Slope RT (%)	N/A
			N/A	Flare Traversable RT?	N/A
			N/A	DWS Provided?	N/A
			N/A	DWS Contrast?	N/A
			N/A	DWS Length (in)	N/A
			N/A	DWS Full Width?	N/A
			N/A	DWS Offset (in)	N/A
			N/A	Gutter Ponding?	N/A
			N/A	Gutter Lip Ht (in)	N/A
<p>Total Cost:</p> <p>\$ 1850.00</p>			No	Painted X Walk1?	N/A
			To E	X Walk 2 Direction	N/A
			N/A	X Walk 2 Width (in)	N/A

4.1	X Walk 2 Slope (%)	N/A
			0.2	X Walk 2 X Slope (%)	N/A
			N/A	Ramp inside XWalk1?	N/A
			N/A	Ramp inside XWalk2?	N/A
			N/A	Clear Space?	N/A
			N/A	Clear Space to XWalk (in)	N/A
			N/A	Storm Grate/Utility Hazard?	N/A
<p>Obstruction Type</p> <p>N/A</p>			N/A	Storm Grate/Utility Type	N/A
			N/A	Surface Condition? (G/P)	Good
