Intersection ID: 48002	Main Street: THELEMA_LN	Cross Street: CLYMER_CT	Location:	SW
ADA ID: D7622600ACEB	Ramp Type: PerpDiag	Initial Pass/Fail: Fail	Overall Compliance: No	Severity Score: 33.75

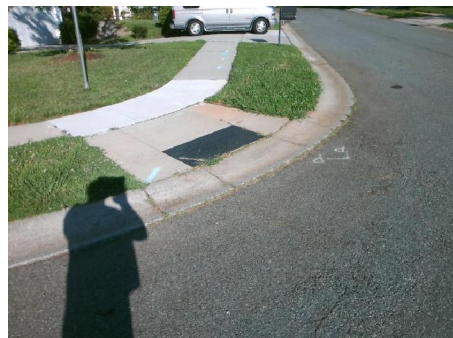
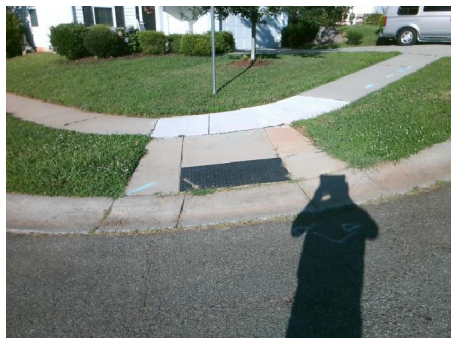
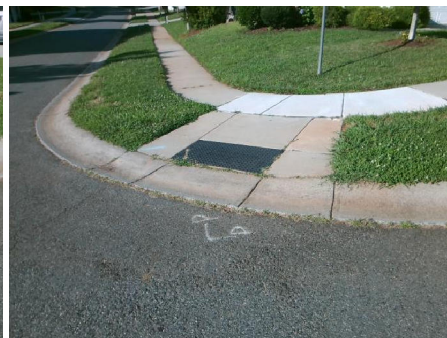
**Not Found, R304.5.1, R304.5.3**

Compliance	Description	Data	Compliance	Description	Data
N/A	Ramp Length (in)	69.0	Yes	Ramp Slope (%)	7.8
No	Ramp Width (in)	47.0	No	Ramp XSlope (%)	8.7
N/A	Flare Type LT	N/A	N/A	Flare Type RT	N/A
N/A	Flare Slope LT (%)	N/A	N/A	Flare Slope RT (%)	N/A
N/A	Flare Traversable LT?	N/A	N/A	Flare Traversable RT?	N/A
N/A	Landing Length (in)	N/A	N/A	DWS Provided?	N/A
N/A	Landing Width (in)	N/A	N/A	DWS Contrast?	N/A
N/A	Landing Slope (%)	N/A	N/A	DWS Length (in)	N/A
N/A	Landing X Slope (%)	N/A	N/A	DWS Full Width?	N/A
N/A	Landing Curb? (Y/N)	N/A	N/A	DWS Offset (in)	N/A
N/A	Shared Landing?	N/A			
N/A	Gutter Ponding?	N/A	N/A	Gutter Slope (%)	N/A
N/A	Gutter Lip Ht (in)	N/A	N/A	Gutter X Slope (%)	N/A
N/A	Painted X Walk1?	No	N/A	Painted X Walk2?	No
	X Walk 1 Direction	To E		X Walk 2 Direction	To N
N/A	X Walk 1 Width (in)	N/A	N/A	X Walk 2 Width (in)	N/A
	X Walk 1 Slope (%)	6.5		X Walk 2 Slope (%)	1.8
	X Walk 1 X Slope (%)	5.3		X Walk 2 X Slope (%)	8.4

N/A	Ramp inside XWalk1?	N/A	N/A	Ramp inside XWalk2?	N/A
	Road Slope (%)	6.8	N/A	Clear Space?	N/A
	Road X Slope (%)	0.9	N/A	Clear Space to XWalk (in)	N/A
N/A	Any Obstructions?	N/A	N/A	Storm Grate/Utility Hazard?	N/A
	Obstruction Type			Storm Grate/Utility Type	
		N/A			N/A
			Yes	Surface Condition? (G/P)	Good

**Remove & Replace Curb Ramp With Two New Directional Ramps or Equivalent.**
