# Access Compliance Report

## Public Rights-of-Way

### (Curb Ramps)

Intersection ID: 9903	Main Street: CRESTMERE_ST	Cross Street: TRIANGLE_DR	Location:	N
ADA ID: D76F9F538375	Ramp Type: Perp	Initial Pass/Fail: Fail	Overall Compliance: No	Severity Score: 12.5

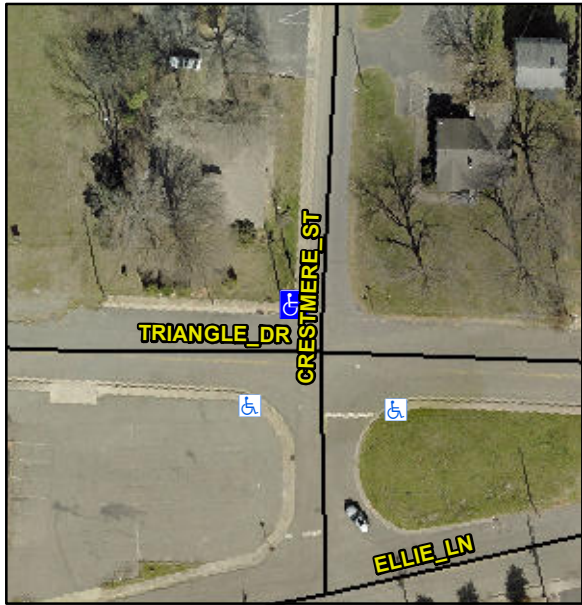
Possible Solutions:		Compliance	Description	Data	Compliance	Description	Data
	Remove & Replace Entire Ramp.		N/A	Ramp Length (in)	57.0	No	Ramp Slope (%)	8.5
			Yes	Ramp Width (in)	63.0	Yes	Ramp XSlope (%)	0.8
			N/A	Flare Type LT	N/A	N/A	Flare Type RT	N/A
			N/A	Flare Slope LT (%)	N/A	N/A	Flare Slope RT (%)	N/A
			N/A	Flare Traversable LT?	N/A	N/A	Flare Traversable RT?	N/A
			N/A	Landing Length (in)	N/A	N/A	DWS Provided?	N/A
			N/A	Landing Width (in)	N/A	N/A	DWS Contrast?	N/A
			N/A	Landing Slope (%)	N/A	N/A	DWS Length (in)	N/A
			N/A	Landing X Slope (%)	N/A	N/A	DWS Full Width?	N/A
Surveyor Notes:		N/A	N/A	Landing Curb? (Y/N)	N/A	N/A	DWS Offset (in)	N/A
PROW/ADA:		Not Found, R304.2.2	N/A	Shared Landing?	N/A			
			N/A	Gutter Ponding?	N/A	N/A	Gutter Slope (%)	N/A
			N/A	Gutter Lip Ht (in)	N/A	N/A	Gutter X Slope (%)	N/A

N/A	Painted X Walk1?	No	N/A	Painted X Walk2?	N/A
				X Walk 1 Direction	To SW		X Walk 2 Direction	N/A
			N/A	X Walk 1 Width (in)	N/A	N/A	X Walk 2 Width (in)	N/A
				X Walk 1 Slope (%)	2.0		X Walk 2 Slope (%)	N/A
				X Walk 1 X Slope (%)	1.1		X Walk 2 X Slope (%)	N/A
			N/A	Ramp inside XWalk1?	N/A	N/A	Ramp inside XWalk2?	N/A
				Road Slope (%)	N/A	N/A	Clear Space?	N/A
				Road X Slope (%)	N/A	N/A	Clear Space to XWalk (in)	N/A
			N/A	Any Obstructions?	N/A	N/A	Storm Grate/Utility Hazard?	N/A
				Obstruction Type			Storm Grate/Utility Type	
						N/A		N/A
						Yes	Surface Condition? (G/P)	Good
Total Cost:		\$ 1850.00
