Access Compliance Report

Public Rights-of-Way

(Curb Ramps)

Intersection ID: 15161	Main Street: DRESDEN_DR_EAST	Cross Street: ROANOKE_AV	Location: NW
ADA ID: D7715FA0B2BD	Ramp Type: Perp	Initial Pass/Fail: Fail	Overall Compliance: No
Codes/Mitigation Info/Possible Solution		Field Measurements/Component Compliance

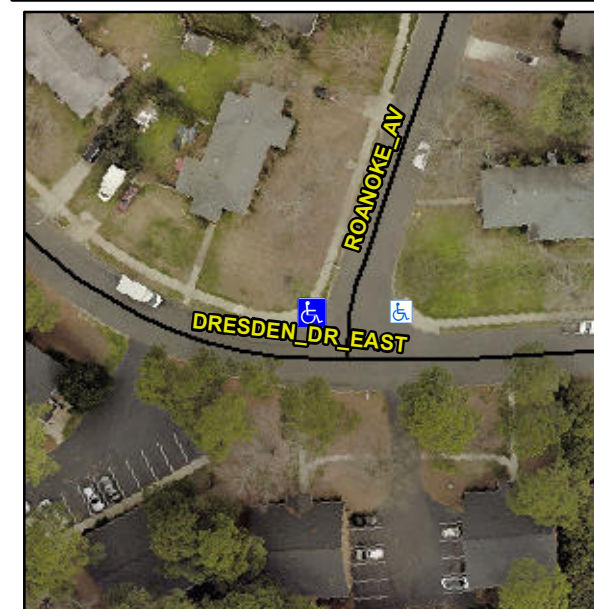
Not Found, R304.5.1, R304.2.2

Compliance	Description	Data	Compliance	Description	Data
N/A	Ramp Length (in)	39.0	No	Ramp Slope (%)	9.8
No	Ramp Width (in)	47.0	Yes	Ramp XSlope (%)	1.2
N/A	Flare Type LT	N/A	N/A	Flare Type RT	N/A
N/A	Flare Slope LT (%)	N/A	N/A	Flare Slope RT (%)	N/A
N/A	Flare Traversable LT?	N/A	N/A	Flare Traversable RT?	N/A
N/A	Landing Length (in)	N/A	N/A	DWS Provided?	N/A
N/A	Landing Width (in)	N/A	N/A	DWS Contrast?	N/A
N/A	Landing Slope (%)	N/A	N/A	DWS Length (in)	N/A
N/A	Landing X Slope (%)	N/A	N/A	DWS Full Width?	N/A
N/A	Landing Curb? (Y/N)	N/A	N/A	DWS Offset (in)	N/A
N/A	Shared Landing?	N/A			
N/A	Gutter Ponding?	N/A	N/A	Gutter Slope (%)	N/A
N/A	Gutter Lip Ht (in)	N/A	N/A	Gutter X Slope (%)	N/A
N/A	Painted X Walk1?	No	N/A	Painted X Walk2?	N/A
	X Walk 1 Direction	To E		X Walk 2 Direction	N/A
N/A	X Walk 1 Width (in)	N/A	N/A	X Walk 2 Width (in)	N/A
	X Walk 1 Slope (%)	1.0		X Walk 2 Slope (%)	N/A
	X Walk 1 X Slope (%)	0.0		X Walk 2 X Slope (%)	N/A

N/A	Ramp inside XWalk1?	N/A	N/A	Ramp inside XWalk2?	N/A
	Road Slope (%)	N/A	N/A	Clear Space?	N/A
	Road X Slope (%)	N/A	N/A	Clear Space to XWalk (in)	N/A
N/A	Any Obstructions?	N/A	N/A	Storm Grate/Utility Hazard?	N/A
	Obstruction Type			Storm Grate/Utility Type	
		N/A			N/A
			Yes	Surface Condition? (G/P)	Good

Remove & Replace Entire Ramp.
