# Access Compliance Report

## Public Rights-of-Way

### (Curb Ramps)

Intersection ID: 31372	Main Street: GREENWAY_VISTA_LN	Cross Street: MCINTYRE_RIDGE_DR	Location: W
ADA ID: D778AEE4AE7C	Ramp Type: Perp	Initial Pass/Fail: Fail	Overall Compliance: No
Severity Score: 17.5			
Codes/Mitigation Info/Possible Solution		Field Measurements/Component Compliance

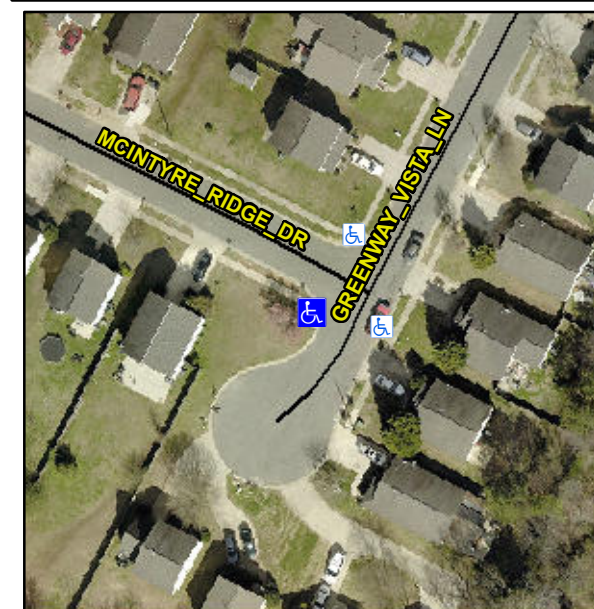
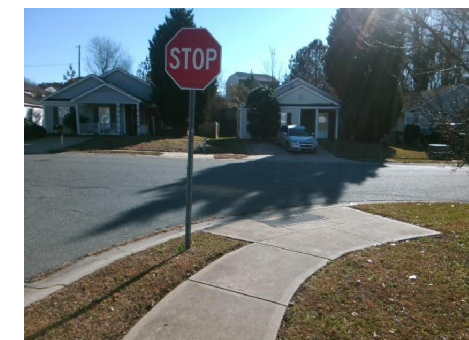
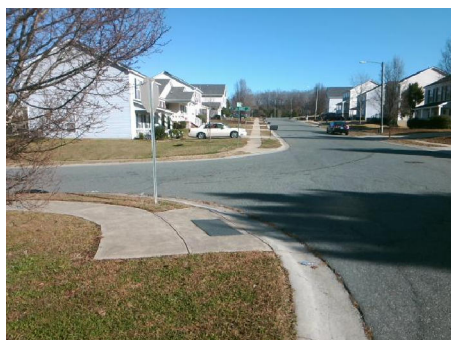
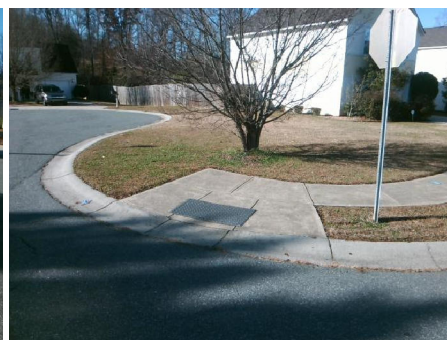
**R304.5.1**

Compliance	Description	Data	Compliance	Description	Data
N/A	Ramp Length (in)	49.0	Yes	Ramp Slope (%)	7.8
No	Ramp Width (in)	35.5	Yes	Ramp XSlope (%)	1.9
N/A	Flare Type LT	N/A	N/A	Flare Type RT	N/A
N/A	Flare Slope LT (%)	N/A	N/A	Flare Slope RT (%)	N/A
N/A	Flare Traversable LT?	N/A	N/A	Flare Traversable RT?	N/A
N/A	Landing Length (in)	N/A	N/A	DWS Provided?	N/A
N/A	Landing Width (in)	N/A	N/A	DWS Contrast?	N/A
N/A	Landing Slope (%)	N/A	N/A	DWS Length (in)	N/A
N/A	Landing X Slope (%)	N/A	N/A	DWS Full Width?	N/A
N/A	Landing Curb? (Y/N)	N/A	N/A	DWS Offset (in)	N/A
N/A	Shared Landing?	N/A			
N/A	Gutter Ponding?	N/A	N/A	Gutter Slope (%)	N/A
N/A	Gutter Lip Ht (in)	N/A	N/A	Gutter X Slope (%)	N/A
N/A	Painted X Walk1?	No	N/A	Painted X Walk2?	N/A
	X Walk 1 Direction	To SE		X Walk 2 Direction	N/A
N/A	X Walk 1 Width (in)	N/A	N/A	X Walk 2 Width (in)	N/A
	X Walk 1 Slope (%)	6.0		X Walk 2 Slope (%)	N/A
	X Walk 1 X Slope (%)	1.1		X Walk 2 X Slope (%)	N/A

**Remove & Replace Entire Ramp.**

Total Cost: \$ 1850.00
