# Access Compliance Report

## Public Rights-of-Way

### (Curb Ramps)

Intersection ID: 18932	Main Street: GLENHAM_DR	Cross Street: TYVOLA_RD	Location: SE
ADA ID: D778AF6E516E	Ramp Type: Perp	Initial Pass/Fail: Fail	Overall Compliance: No
Severity Score: 33.75			
Codes/Mitigation Info/Possible Solution		Field Measurements/Component Compliance

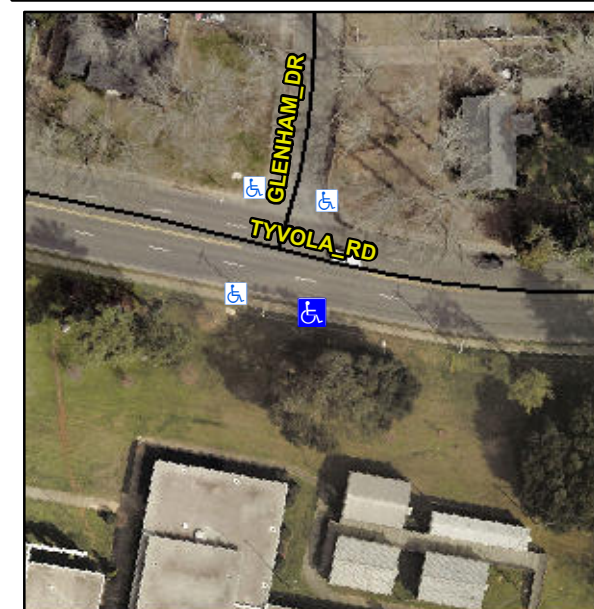
Compliance	Description	Data	Compliance	Description	Data
N/A	Ramp Length (in)	66.0	No	Ramp Slope (%)	12.9
No	Ramp Width (in)	39.0	Yes	Ramp XSlope (%)	1.9
N/A	Flare Type LT	N/A	N/A	Flare Type RT	N/A
N/A	Flare Slope LT (%)	N/A	N/A	Flare Slope RT (%)	N/A
N/A	Flare Traversable LT?	N/A	N/A	Flare Traversable RT?	N/A
N/A	Landing Length (in)	N/A	N/A	DWS Provided?	N/A
N/A	Landing Width (in)	N/A	N/A	DWS Contrast?	N/A
N/A	Landing Slope (%)	N/A	N/A	DWS Length (in)	N/A
N/A	Landing X Slope (%)	N/A	N/A	DWS Full Width?	N/A
N/A	Landing Curb? (Y/N)	N/A	N/A	DWS Offset (in)	N/A
N/A	Shared Landing?	N/A			
N/A	Gutter Ponding?	N/A	N/A	Gutter Slope (%)	N/A
N/A	Gutter Lip Ht (in)	N/A	N/A	Gutter X Slope (%)	N/A
N/A	Painted X Walk1?	No	N/A	Painted X Walk2?	N/A
	X Walk 1 Direction	To N		X Walk 2 Direction	N/A
N/A	X Walk 1 Width (in)	N/A	N/A	X Walk 2 Width (in)	N/A
	X Walk 1 Slope (%)	6.2		X Walk 2 Slope (%)	N/A
	X Walk 1 X Slope (%)	0.1		X Walk 2 X Slope (%)	N/A

N/A	Ramp inside XWalk1?	N/A	N/A	Ramp inside XWalk2?	N/A
	Road Slope (%)	N/A	N/A	Clear Space?	N/A
	Road X Slope (%)	N/A	N/A	Clear Space to XWalk (in)	N/A
N/A	Any Obstructions?	N/A	N/A	Storm Grate/Utility Hazard?	N/A
	Obstruction Type			Storm Grate/Utility Type	
		N/A			N/A
			Yes	Surface Condition? (G/P)	Good

Possible Solutions:

**Remove & Replace Entire Ramp.**

**R304.5.1, R304.2.2**
