Access Compliance Report

Public Rights-of-Way

(Curb Ramps)

Intersection ID: N/A	Main Street: CANTERBURY CASTLE DR	Cross Street: SAGMORE HILL DR	Location: NE
ADA ID: D78973234B2B	Ramp Type: Perp	Initial Pass/Fail: Fail	Overall Compliance: No
Severity Score: 10			
Codes/Mitigation Info/Possible Solution		Field Measurements/Component Compliance

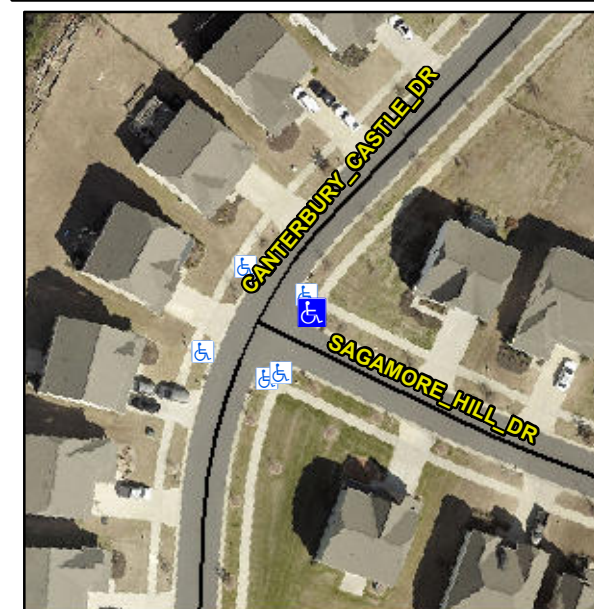
Not Found, R304.5.1, R304.5.3

Compliance	Description	Data	Compliance	Description	Data
N/A	Ramp Length (in)	98.0	Yes	Ramp Slope (%)	5.4
No	Ramp Width (in)	47.0	No	Ramp XSlope (%)	2.9
N/A	Flare Type LT	N/A	N/A	Flare Type RT	N/A
N/A	Flare Slope LT (%)	N/A	N/A	Flare Slope RT (%)	N/A
N/A	Flare Traversable LT?	N/A	N/A	Flare Traversable RT?	N/A
N/A	Landing Length (in)	N/A	N/A	DWS Provided?	N/A
N/A	Landing Width (in)	N/A	N/A	DWS Contrast?	N/A
N/A	Landing Slope (%)	N/A	N/A	DWS Length (in)	N/A
N/A	Landing X Slope (%)	N/A	N/A	DWS Full Width?	N/A
N/A	Landing Curb? (Y/N)	N/A	N/A	DWS Offset (in)	N/A
N/A	Shared Landing?	N/A			
N/A	Gutter Ponding?	N/A	N/A	Gutter Slope (%)	N/A
N/A	Gutter Lip Ht (in)	N/A	N/A	Gutter X Slope (%)	N/A
N/A	Painted X Walk1?	No	N/A	Painted X Walk2?	N/A
	X Walk 1 Direction	To SW		X Walk 2 Direction	N/A
N/A	X Walk 1 Width (in)	N/A	N/A	X Walk 2 Width (in)	N/A
	X Walk 1 Slope (%)	3.5		X Walk 2 Slope (%)	N/A
	X Walk 1 X Slope (%)	0.3		X Walk 2 X Slope (%)	N/A

Remove & Replace Entire Ramp.
