Intersection ID: 11994	Main Street: BELVEDERE_AV	Cross Street: THE_PLAZA	Location:	SW
ADA ID: D7931B264C2D	Ramp Type: Perp	Initial Pass/Fail: Fail	Overall Compliance: No	Severity Score: 10

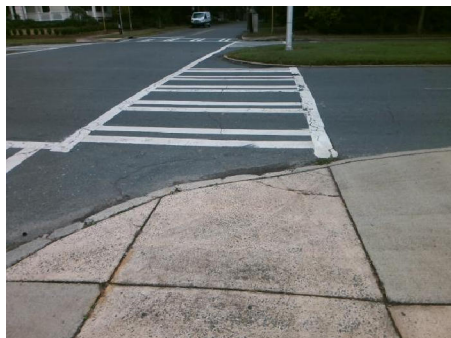
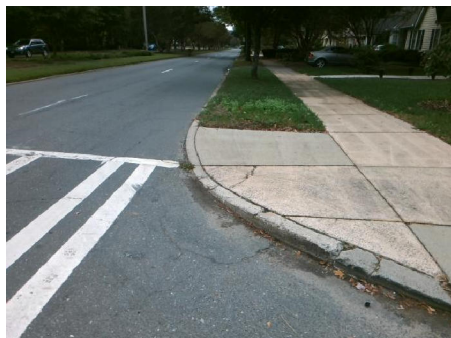
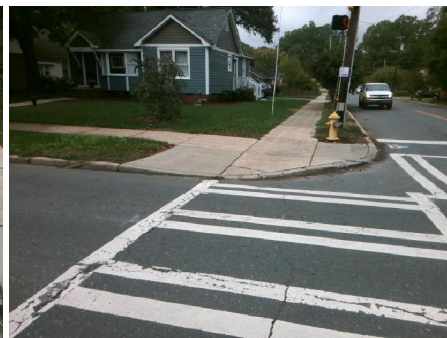
Possible Solutions:		Compliance	Description	Data	Compliance	Description	Data
	Remove & Replace Entire Ramp.		N/A	Ramp Length (in)	45.0	Yes	Ramp Slope (%)	5.1
			No	Ramp Width (in)	36.0	No	Ramp XSlope (%)	3.2
			N/A	Flare Type LT	N/A	N/A	Flare Type RT	N/A
			N/A	Flare Slope LT (%)	N/A	N/A	Flare Slope RT (%)	N/A
			N/A	Flare Traversable LT?	N/A	N/A	Flare Traversable RT?	N/A
			N/A	Landing Length (in)	N/A	N/A	DWS Provided?	N/A
			N/A	Landing Width (in)	N/A	N/A	DWS Contrast?	N/A
			N/A	Landing Slope (%)	N/A	N/A	DWS Length (in)	N/A
			N/A	Landing X Slope (%)	N/A	N/A	DWS Full Width?	N/A
Surveyor Notes:	N/A		N/A	Landing Curb? (Y/N)	N/A	N/A	DWS Offset (in)	N/A
			N/A	Shared Landing?	N/A			
			N/A	Gutter Ponding?	N/A	N/A	Gutter Slope (%)	N/A
			N/A	Gutter Lip Ht (in)	N/A	N/A	Gutter X Slope (%)	N/A
			N/A	Painted X Walk1?	Yes	N/A	Painted X Walk2?	N/A

X Walk 1 Direction	To E		X Walk 2 Direction	N/A
			N/A	X Walk 1 Width (in)	114.0	N/A	X Walk 2 Width (in)	N/A
				X Walk 1 Slope (%)	6.4		X Walk 2 Slope (%)	N/A
				X Walk 1 X Slope (%)	1.3		X Walk 2 X Slope (%)	N/A
			N/A	Ramp inside XWalk1?	Yes	N/A	Ramp inside XWalk2?	N/A
PROW/ADA:	R304.5.1, R304.5.3			Road Slope (%)	N/A	N/A	Clear Space?	N/A
				Road X Slope (%)	N/A	N/A	Clear Space to XWalk (in)	N/A
			N/A	Any Obstructions?	N/A	N/A	Storm Grate/Utility Hazard?	N/A
				Obstruction Type			Storm Grate/Utility Type	
					N/A			N/A
						Yes	Surface Condition? (G/P)	Good
	Total Cost:		\$	1850.00
