Access Compliance Report

Public Rights-of-Way

(Curb Ramps)

Intersection ID: 9396	Main Street: MORETZ_AV	Cross Street: N_GRAHAM_ST	Location:	N
ADA ID: D79ED83F196F	Ramp Type: PerpDiag	Initial Pass/Fail: Fail	Overall Compliance: No	Severity Score: 10
Codes/Mitigation Info/Possible Solution		Field Measurements/Component Compliance

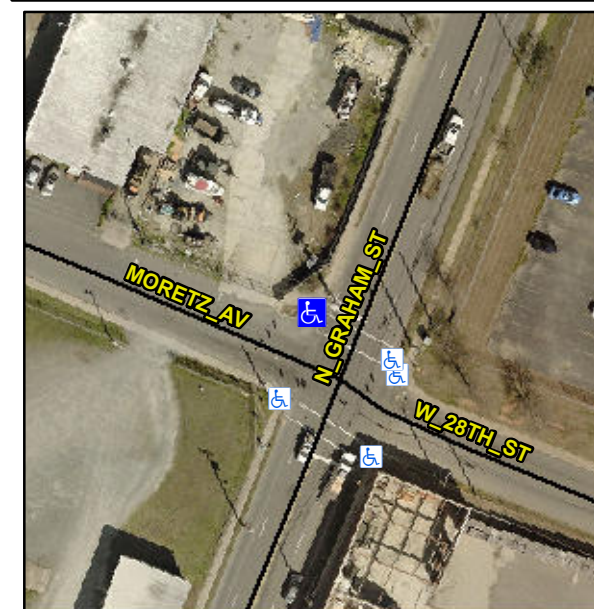
Not Found, R304.5.1

Compliance	Description	Data	Compliance	Description	Data
N/A	Ramp Length (in)	71.5	Yes	Ramp Slope (%)	5.5
No	Ramp Width (in)	44.0	Yes	Ramp XSlope (%)	3.0
N/A	Flare Type LT	N/A	N/A	Flare Type RT	N/A
N/A	Flare Slope LT (%)	N/A	N/A	Flare Slope RT (%)	N/A
N/A	Flare Traversable LT?	N/A	N/A	Flare Traversable RT?	N/A
N/A	Landing Length (in)	N/A	N/A	DWS Provided?	N/A
N/A	Landing Width (in)	N/A	N/A	DWS Contrast?	N/A
N/A	Landing Slope (%)	N/A	N/A	DWS Length (in)	N/A
N/A	Landing X Slope (%)	N/A	N/A	DWS Full Width?	N/A
N/A	Landing Curb? (Y/N)	N/A	N/A	DWS Offset (in)	N/A
N/A	Shared Landing?	N/A			
N/A	Gutter Ponding?	N/A	N/A	Gutter Slope (%)	N/A
N/A	Gutter Lip Ht (in)	0.5	N/A	Gutter X Slope (%)	N/A
N/A	Painted X Walk1?	No	N/A	Painted X Walk2?	Yes
	X Walk 1 Direction	To SW		X Walk 2 Direction	To SE
N/A	X Walk 1 Width (in)	N/A	N/A	X Walk 2 Width (in)	113.0
	X Walk 1 Slope (%)	0.7		X Walk 2 Slope (%)	2.5
	X Walk 1 X Slope (%)	4.7		X Walk 2 X Slope (%)	0.7

N/A	Ramp inside XWalk1?	N/A	N/A	Ramp inside XWalk2?	Yes
	Road Slope (%)	5.5	N/A	Clear Space?	N/A
	Road X Slope (%)	2.0	N/A	Clear Space to XWalk (in)	N/A
N/A	Any Obstructions?	N/A	N/A	Storm Grate/Utility Hazard?	N/A
	Obstruction Type			Storm Grate/Utility Type	
		N/A			N/A
			Yes	Surface Condition? (G/P)	Good

Possible Solutions:

Remove & Replace Curb Ramp With Two New Directional Ramps or Equivalent.

Total Cost: \$ 3200.00
