# Access Compliance Report

## Public Rights-of-Way

| Intersection ID: 45756 | Main Street: CHRISTENBURY_RD | Cross Street: GRANDEUR_RD | Location: SW |
| ADA ID: D7BB9C1453BF | Ramp Type: PerpDiag | Initial Pass/Fail: Fail | Overall Compliance: No |

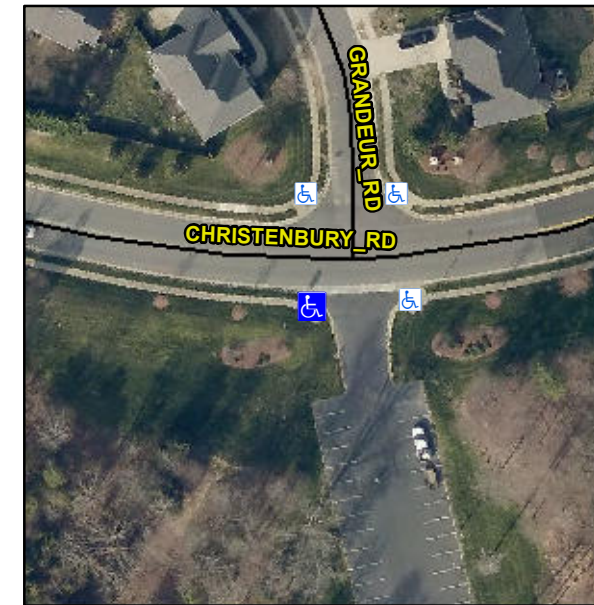
| | | Severity Score: 10 | |

**R304.5.1, R304.5.3**

| Compliance | Description | Data | Compliance | Description | Data |
|---|---|---|---|---|---|
| N/A | Ramp Length (in) | 47.0 | Yes | Ramp Slope (%) | 5.7 |
| No | Ramp Width (in) | 47.0 | No | Ramp XSlope (%) | 3.1 |

**Remove & Replace Curb Ramp With Two New Directional Ramps or Equivalent.**
