## Access Compliance Report Public Rights-of-Way (Curb Ramps)

Intersection ID: 13848Main Street:CENTRAL\_AVCross Street:MEDALLION\_DRLocation:NEADA ID: D7C09AC19BCFRamp Type:PerpInitial Pass/Fail:FailOverall Compliance:NoSeverity Score:10

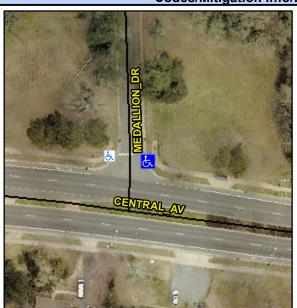
a55/F	ali. Fali Overali	Compilan	ice. N	o Severity Score.				
Field Measurements/Component Compliance								
Com	oliance Description	Data	Comp	liance Description	Data			
N/A	Ramp Length (in)	72.0	Yes	Ramp Slope (%)	5.5			
No	Ramp Width (in)	36.0	No	Ramp XSlope (%)	2.6			
N/A	Flare Type LT	N/A	N/A	Flare Type RT	N/A			
N/A	Flare Slope LT (%)	N/A	N/A	Flare Slope RT (%)	N/A			
N/A	Flare Traversable LT?	N/A	N/A	Flare Traversable RT?	N/A			
N/A	Landing Length (in)	N/A	N/A	DWS Provided?	N/A			
N/A	Landing Width (in)	N/A	N/A	DWS Contrast?	N/A			
N/A	Landing Slope (%)	N/A	N/A	DWS Length (in)	N/A			
N/A	Landing X Slope (%)	N/A	N/A	DWS Full Width?	N/A			
N/A	Landing Curb? (Y/N)	N/A	N/A	DWS Offset (in)	N/A			
N/A	Shared Landing?	N/A						
N/A	Gutter Ponding?	N/A	N/A	Gutter Slope (%)	N/A			
N/A	Gutter Lip Ht (in)	N/A	N/A	Gutter X Slope (%)	N/A			
N/A	Painted X Walk1?	No	N/A	Painted X Walk2?	N/A			
	X Walk 1 Direction	To NW		X Walk 2 Direction	N/A

N/A	X Walk 1 Width (in)	N/A	N/A	X Walk 2 Width (in)	N/A			
	X Walk 1 Slope (%)	1.1		X Walk 2 Slope (%)	N/A			
	X Walk 1 X Slope (%)	1.6		X Walk 2 X Slope (%)	N/A			
N/A	Ramp inside XWalk1?	N/A	N/A	Ramp inside XWalk2?	N/A			
	Road Slope (%)	N/A	N/A	Clear Space?	N/A			
	Road X Slope (%)	N/A	N/A	Clear Space to XWalk (in)	N/A			
N/A	Any Obstructions?	N/A	N/A	Storm Grate/Utility Hazard?	N/A			
	Obstruction Type		l	Storm Grate/Utility Type				
		N/A			N/A			
			Yes	Surface Condition? (G/P)	Good

Possible Solutions:	9
Remove & Replace Entire Ramp.	N
	N
	N
	N
	N
	N
Surveyor Notes:	N
N/A	N
	N
	N
	N
PROW/ADA:	N
Not Found, R304.5.1, R304.5.3	N
	N
	N
	N
