# Access Compliance Report

## Public Rights-of-Way

### (Curb Ramps)

Intersection ID: 15051	Main Street: FILLMORE_AV	Cross Street: KENILWORTH_AV	Location: S
ADA ID: D7C904EE2C06	Ramp Type: Directional1	Initial Pass/Fail: Fail	Overall Compliance: No
Codes/Mitigation Info/Possible Solution		Field Measurements/Component Compliance	
Severity Score: 13.75

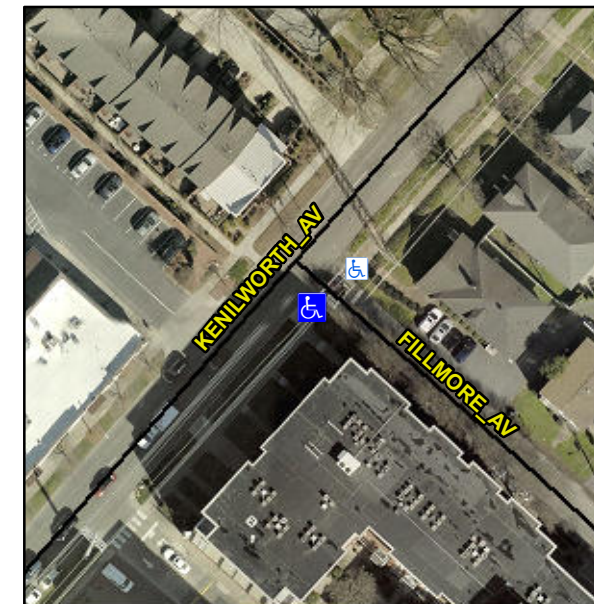
**UNMODIFIED CURB, CURB LIP 1.0"**

**R304.2.2, R304.5.3**

Compliance	Description	Data	Compliance	Description	Data
N/A	Ramp Length (in)	69.0	N/A	Grade Break?	N/A
Yes	Ramp Width (in)	56.0	N/A	Grade Break Slope (%)	0.0
No	Ramp Slope (%)	9.7	N/A	Grade Break XSlope (%)	0.0
No	Ramp XSlope (%)	2.7			
N/A	Flare Type LT	N/A	N/A	Flare Type RT	N/A
N/A	Flare Slope LT (%)	N/A	N/A	Flare Slope RT (%)	0.0
N/A	Flare Traversable LT?	N/A	N/A	Flare Traversable RT?	N/A
N/A	Landing Length (in)	0.0	N/A	DWS Provided?	N/A
N/A	Landing Width (in)	0.0	N/A	DWS Contrast?	N/A
N/A	Landing Slope (%)	0.0	N/A	DWS Length (in)	N/A
N/A	Landing X Slope (%)	0.0	N/A	DWS Full Width?	N/A
N/A	Landing Curb? (Y/N)	N/A	N/A	DWS Offset LT (in)	N/A
N/A	Shared Landing?	N/A	N/A	DWS Offset RT (in)	N/A
N/A	Gutter Ponding?	0.0	N/A	Gutter Slope (%)	N/A
N/A	Gutter Lip Ht (in)	0.0	N/A	Gutter X Slope (%)	N/A
N/A	Painted X Walk1?	Yes		Road Slope (%)	4.3
	X Walk 1 Direction	To NE		Road X Slope (%)	0.5
	X Walk 1 Width (in)	109.0		Clear Space?	N/A

X Walk 1 Slope (%)	4.3	N/A	Clear Space to XWalk (in)	N/A
	X Walk 1 X Slope (%)	0.5	N/A	Storm Grate/Utility Hazard?	N/A
N/A	Ramp inside XWalk1?	Yes		Storm Grate/Utility Type	
N/A	Any Obstructions?	N/A			N/A
	Obstruction Type		Yes	Surface Condition? (G/P)	Good
			N/A	Curb Slope (%)	8.8

**Remove & Replace Entire Ramp.**
