Access Compliance Report Public Rights-of-Way (Curb Ramps)

Intersection ID: 31876 Main Street: ARABELLA DR Cross Street: WILLIAMS_GLENN_RD Location: SW **Severity Score:** ADA ID: D7D968330A07 Ramp Type: Perp Initial Pass/Fail: Fail **Overall Compliance: No** 12.5

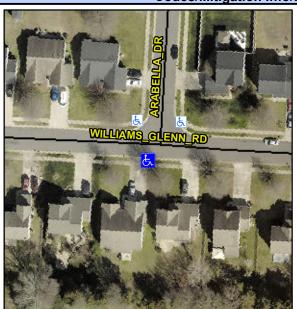
Field Measurements/Component Compliance							
Comp	Data	Comp	liance Description	Data			
N/A	Ramp Length (in)	47.0	Yes	Ramp Slope (%)	6.7		
Yes	Ramp Width (in)	48.0	No	Ramp XSlope (%)	5.8		
N/A	Flare Type LT	N/A	N/A	Flare Type RT	N/A		
N/A	Flare Slope LT (%)	N/A	N/A	Flare Slope RT (%)	N/A		
N/A	Flare Traversable LT?	N/A	N/A	Flare Traversable RT?	N/A		
N/A	Landing Length (in)	N/A	N/A	DWS Provided?	N/A		
N/A	Landing Width (in)	N/A	N/A	DWS Contrast?	N/A		
N/A	Landing Slope (%)	N/A	N/A	DWS Length (in)	N/A		
N/A	Landing X Slope (%)	N/A	N/A	DWS Full Width?	N/A		
N/A	Landing Curb? (Y/N)	N/A	N/A	DWS Offset (in)	N/A		
N/A	Shared Landing?	N/A					
N/A	Gutter Ponding?	N/A	N/A	Gutter Slope (%)	N/A		
N/A	Gutter Lip Ht (in)	N/A	N/A	Gutter X Slope (%)	N/A		
N/A	Painted X Walk1?	No	N/A	Painted X Walk2?	N/A		
	X Walk 1 Direction	To NW		X Walk 2 Direction	N/A		
N/A	X Walk 1 Width (in)	N/A	N/A	X Walk 2 Width (in)	N/A		
	X Walk 1 Slope (%)	3.5		X Walk 2 Slope (%)	N/A

X Walk 1 X Slope (%)	0.9		X Walk 2 X Slope (%)	N/A		
N/A	Ramp inside XWalk1?	N/A	N/A	Ramp inside XWalk2?	N/A		
	Road Slope (%)	N/A	N/A	Clear Space?	N/A		
	Road X Slope (%)	N/A	N/A	Clear Space to XWalk (in)	N/A		
N/A	Any Obstructions?	N/A	N/A	Storm Grate/Utility Hazard?	N/A		
	Obstruction Type			Storm Grate/Utility Type			
		N/A			N/A		
			Yes	Surface Condition? (G/P)	Good

<u> </u>	1 CSSIBIC COIGHOIT
B	Possible Solutions:
- 1	Remove & Replace Entire Ramp.
N.	
26	Surveyor Notes:
金 一	N/A
	PROW/ADA:
	R304.5.3
