## **Access Compliance Report Public Rights-of-Way** (Curb Ramps)

Intersection ID: 50304 Main Street: PINE\_TERRACE\_CT Cross Street: S\_J\_LAWRENCE\_RD Location: NW **Severity Score:** ADA ID: D7DEF59299B3 Ramp Type: PerpDiag Initial Pass/Fail: Fail **Overall Compliance: No** 8.75

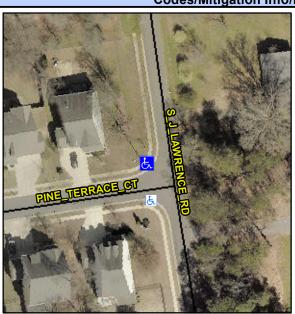
Field Measurements/Component Compliance								
	Compliance Description		tion Data Compliance Description		liance Description	Data		
	N/A	Ramp Length (in)	49.0	Yes	Ramp Slope (%)	5.2		
	No	Ramp Width (in)	47.0	Yes	Ramp XSlope (%)	0.4		
	N/A	Flare Type LT	N/A	N/A	Flare Type RT	N/A		
	N/A	Flare Slope LT (%)	N/A	N/A	Flare Slope RT (%)	N/A		
	N/A	Flare Traversable LT?	N/A	N/A	Flare Traversable RT?	N/A		
	N/A	Landing Length (in)	N/A	N/A	DWS Provided?	N/A		
	N/A	Landing Width (in)	N/A	N/A	DWS Contrast?	N/A		
	N/A	Landing Slope (%)	N/A	N/A	DWS Length (in)	N/A		
	N/A	Landing X Slope (%)	N/A	N/A	DWS Full Width?	N/A		
	N/A	Landing Curb? (Y/N)	N/A	N/A	DWS Offset (in)	N/A		
	N/A	Shared Landing?	N/A					
	N/A	Gutter Ponding?	N/A	N/A	Gutter Slope (%)	N/A		
	N/A	Gutter Lip Ht (in)	N/A	N/A	Gutter X Slope (%)	N/A		
	N/A	Painted X Walk1?	No	N/A	Painted X Walk2?	No		
		X Walk 1 Direction	To S		X Walk 2 Direction	То Е		
	N/A	X Walk 1 Width (in)	N/A	N/A	X Walk 2 Width (in)	N/A

X Walk 1 Slope (%)	1.6		X Walk 2 Slope (%)	0.6		
		X Walk 1 X Slope (%)	0.2		X Walk 2 X Slope (%)	2.1		
	N/A	Ramp inside XWalk1?	N/A	N/A	Ramp inside XWalk2?	N/A		
		Road Slope (%)	1.0	N/A	Clear Space?	N/A		
		Road X Slope (%)	0.4	N/A	Clear Space to XWalk (in)	N/A		
	N/A	Any Obstructions?	N/A	N/A	Storm Grate/Utility Hazard?	N/A		
		Obstruction Type			Storm Grate/Utility Type			
			N/A			N/A		
				Yes	Surface Condition? (G/P)	Good		
T 20

Possible Solution				
Possible Solutions:	Co			
Remove & Replace Curb Ramp With Two New Directional Ramps or				
	N/A			
	N/A			
	N/A			
Surveyor Notes:	N/A			
N/A	N/A			
	N/A			
	N/A			
	N/A			
PROW/ADA:				
Not Found, R304.5.1	N/A			
,				
	N/A			
	N/A

Total Cost: 3200.00
