Access Compliance Report

Public Rights-of-Way

| Intersection ID: 11676 | Main Street: HAWTHORNE_LN | Cross Street: PARKWOOD_AV | Location: SE |
| ADA ID: D7DEFCD43C23 | Ramp Type: Perp | Initial Pass/Fail: Fail | Overall Compliance: No |

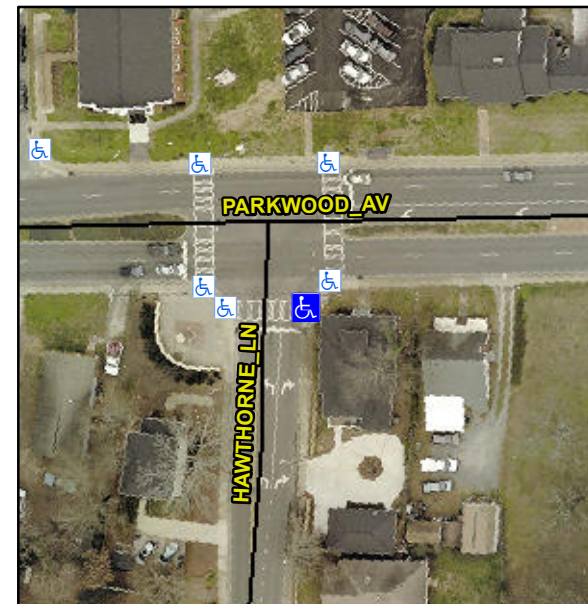
Not Found, R304.5.1

| Compliance | Description | Data | Compliance | Description | Data |
|---|---|---|---|---|---|
| N/A | Ramp Length (in) | 62.5 | Yes | Ramp Slope (%) | 7.8 |
| No | Ramp Width (in) | 47.5 | Yes | Ramp XSlope (%) | 0.1 |

Remove & Replace Entire Ramp.
