Access Compliance Report

Public Rights-of-Way

(Curb Ramps)

Intersection ID: 48166	Main Street: NORTHLAKE_MALL_DR	Cross Street: NORTHLAKE_CENTRE_PY	Location: SE
ADA ID: D7E5D2A75227	Ramp Type: Perp	Initial Pass/Fail: Fail	Overall Compliance: No
Severity Score: 37.5			
Codes/Mitigation Info/Possible Solution		Field Measurements/Component Compliance

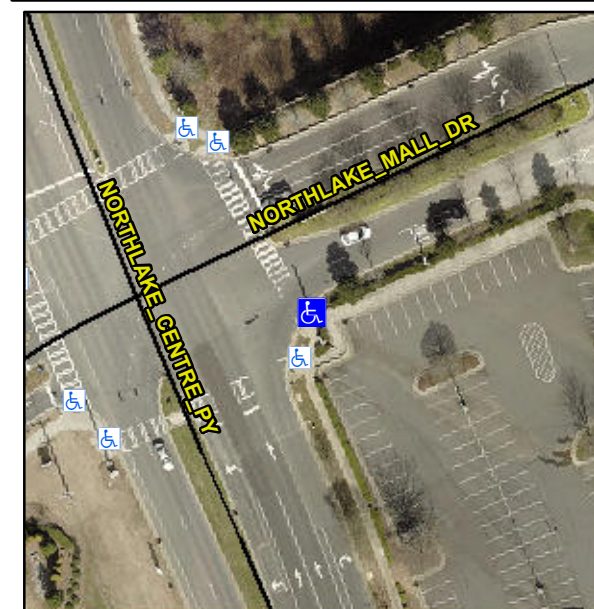
Not Found, R304.2.2, R304.5.3

Compliance	Description	Data	Compliance	Description	Data
N/A	Ramp Length (in)	54.0	No	Ramp Slope (%)	13.3
Yes	Ramp Width (in)	54.0	No	Ramp XSlope (%)	5.2
N/A	Flare Type LT	N/A	N/A	Flare Type RT	N/A
N/A	Flare Slope LT (%)	N/A	N/A	Flare Slope RT (%)	N/A
N/A	Flare Traversable LT?	N/A	N/A	Flare Traversable RT?	N/A
N/A	Landing Length (in)	N/A	N/A	DWS Provided?	N/A
N/A	Landing Width (in)	N/A	N/A	DWS Contrast?	N/A
N/A	Landing Slope (%)	N/A	N/A	DWS Length (in)	N/A
N/A	Landing X Slope (%)	N/A	N/A	DWS Full Width?	N/A
N/A	Landing Curb? (Y/N)	N/A	N/A	DWS Offset (in)	N/A
N/A	Shared Landing?	N/A			
N/A	Gutter Ponding?	N/A	N/A	Gutter Slope (%)	N/A
N/A	Gutter Lip Ht (in)	N/A	N/A	Gutter X Slope (%)	N/A
N/A	Painted X Walk1?	Yes	N/A	Painted X Walk2?	N/A
	X Walk 1 Direction	To N		X Walk 2 Direction	N/A
N/A	X Walk 1 Width (in)	103.0	N/A	X Walk 2 Width (in)	N/A
	X Walk 1 Slope (%)	5.8		X Walk 2 Slope (%)	N/A
	X Walk 1 X Slope (%)	1.5		X Walk 2 X Slope (%)	N/A

N/A	Ramp inside XWalk1?	Yes	N/A	Ramp inside XWalk2?	N/A
	Road Slope (%)	N/A	N/A	Clear Space?	N/A
	Road X Slope (%)	N/A	N/A	Clear Space to XWalk (in)	N/A
N/A	Any Obstructions?	N/A	N/A	Storm Grate/Utility Hazard?	N/A
	Obstruction Type			Storm Grate/Utility Type	
		N/A			N/A
		Yes		Surface Condition? (G/P)	Good

Possible Solutions:

Remove & Replace Entire Ramp.
