Access Compliance Report

Public Rights-of-Way

(Curb Ramps)

Intersection ID: 28386	Main Street: MARVIN_RD	Cross Street: SOUTHAMPTON_COMMONS_DR	Location: E
ADA ID: D7EF017749AD	Ramp Type: Perp	Initial Pass/Fail: Fail	Overall Compliance: No
Severity Score: 10			
Codes/Mitigation Info/Possible Solution		Field Measurements/Component Compliance

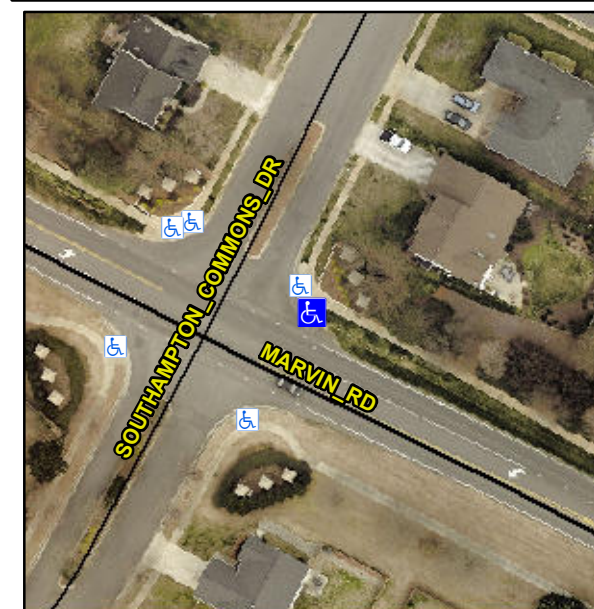
Not Found, R304.5.1, R304.5.3

Compliance	Description	Data	Compliance	Description	Data
N/A	Ramp Length (in)	69.0	Yes	Ramp Slope (%)	5.4
No	Ramp Width (in)	41.0	No	Ramp XSlope (%)	2.9
N/A	Flare Type LT	N/A	N/A	Flare Type RT	N/A
N/A	Flare Slope LT (%)	N/A	N/A	Flare Slope RT (%)	N/A
N/A	Flare Traversable LT?	N/A	N/A	Flare Traversable RT?	N/A
N/A	Landing Length (in)	N/A	N/A	DWS Provided?	N/A
N/A	Landing Width (in)	N/A	N/A	DWS Contrast?	N/A
N/A	Landing Slope (%)	N/A	N/A	DWS Length (in)	N/A
N/A	Landing X Slope (%)	N/A	N/A	DWS Full Width?	N/A
N/A	Landing Curb? (Y/N)	N/A	N/A	DWS Offset (in)	N/A
N/A	Shared Landing?	N/A			
N/A	Gutter Ponding?	N/A	N/A	Gutter Slope (%)	N/A
N/A	Gutter Lip Ht (in)	N/A	N/A	Gutter X Slope (%)	N/A
N/A	Painted X Walk1?	No	N/A	Painted X Walk2?	N/A
	X Walk 1 Direction	To SW		X Walk 2 Direction	N/A
N/A	X Walk 1 Width (in)	N/A	N/A	X Walk 2 Width (in)	N/A
	X Walk 1 Slope (%)	1.9		X Walk 2 Slope (%)	N/A
	X Walk 1 X Slope (%)	0.4		X Walk 2 X Slope (%)	N/A

N/A	Ramp inside XWalk1?	N/A	N/A	Ramp inside XWalk2?	N/A
	Road Slope (%)	N/A	N/A	Clear Space?	N/A
	Road X Slope (%)	N/A	N/A	Clear Space to XWalk (in)	N/A
N/A	Any Obstructions?	N/A	N/A	Storm Grate/Utility Hazard?	N/A
	Obstruction Type			Storm Grate/Utility Type	
		N/A			N/A
			Yes	Surface Condition? (G/P)	Good

Possible Solutions:

Remove & Replace Entire Ramp.
