Access Compliance Report

Public Rights-of-Way

(Curb Ramps)

Intersection ID: 10022610	Main Street: CARMEL_RD	Cross Street: N/A	Location: N
ADA ID: D7F62747CEC2	Ramp Type: PerpDiag	Initial Pass/Fail: Fail	Overall Compliance: No
		Severity Score: 25

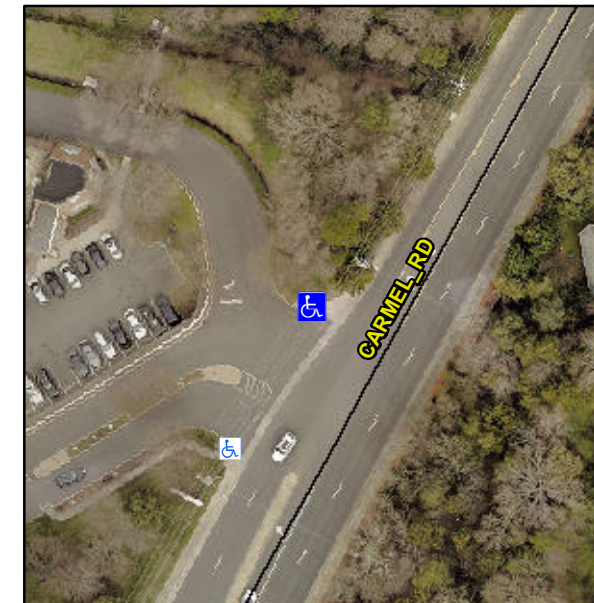
Compliance	Description	Data	Compliance	Description	Data
N/A	Ramp Length (in)	59.0	No	Ramp Slope (%)	9.7
Yes	Ramp Width (in)	48.0	No	Ramp XSlope (%)	6.1
N/A	Flare Type LT	N/A	N/A	Flare Type RT	N/A
N/A	Flare Slope LT (%)	N/A	N/A	Flare Slope RT (%)	N/A
N/A	Flare Traversable LT?	N/A	N/A	Flare Traversable RT?	N/A
N/A	Landing Length (in)	N/A	N/A	DWS Provided?	N/A
N/A	Landing Width (in)	N/A	N/A	DWS Contrast?	N/A
N/A	Landing Slope (%)	N/A	N/A	DWS Length (in)	N/A
N/A	Landing X Slope (%)	N/A	N/A	DWS Full Width?	N/A
N/A	Landing Curb? (Y/N)	N/A	N/A	DWS Offset (in)	N/A
N/A	Shared Landing?	N/A			
N/A	Gutter Ponding?	N/A	N/A	Gutter Slope (%)	N/A
N/A	Gutter Lip Ht (in)	N/A	N/A	Gutter X Slope (%)	N/A
N/A	Painted X Walk1?	No	N/A	Painted X Walk2?	No
	X Walk 1 Direction	To SW		X Walk 2 Direction	To SE
N/A	X Walk 1 Width (in)	N/A	N/A	X Walk 2 Width (in)	N/A
	X Walk 1 Slope (%)	3.5		X Walk 2 Slope (%)	5.8
	X Walk 1 X Slope (%)	6.6		X Walk 2 X Slope (%)	1.7

N/A	Ramp inside XWalk1?	N/A	N/A	Ramp inside XWalk2?	N/A
	Road Slope (%)	8.9	N/A	Clear Space?	N/A
	Road X Slope (%)	4.9	N/A	Clear Space to XWalk (in)	N/A
N/A	Any Obstructions?	N/A	N/A	Storm Grate/Utility Hazard?	N/A
	Obstruction Type			Storm Grate/Utility Type	
		N/A			N/A
			Yes	Surface Condition? (G/P)	Good

Remove & Replace Curb Ramp With Two New Directional Ramps or Equivalent.

R304.2.2, R304.5.3
