# Access Compliance Report

## Public Rights-of-Way

### (Curb Ramps)

| Intersection ID: 48946 | Main Street: DAVID_JENNINGS_AV | Cross Street: MITCHELL_GRANT_WY | Location: S |

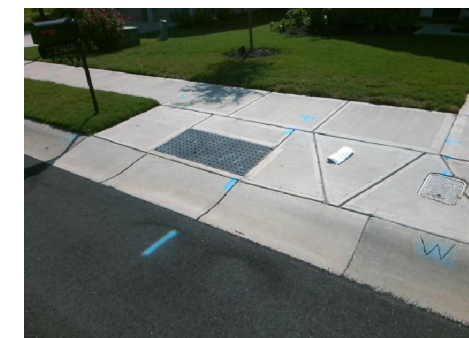
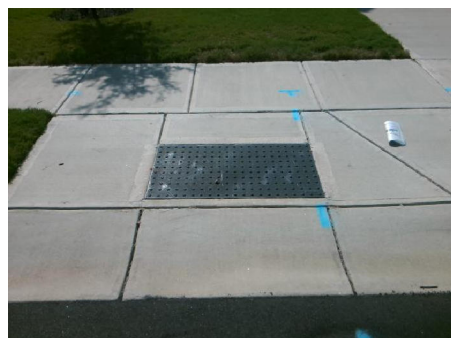
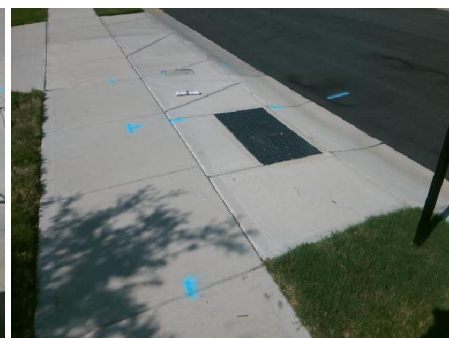
| ADA ID: D7F64B58E745 | Ramp Type: Perp | Initial Pass/Fail: Fail | Overall Compliance: No |

**Not Found, R304.5.1**

| Compliance | Description | Data | Compliance | Description | Data |
|---|---|---|---|---|---|
| No | Ramp Width (in) | 47.0 | Yes | Ramp XSlope (%) | 1.0 |

**Remove & Replace Entire Ramp.**

Total Cost: \$ 1850.00
