# Access Compliance Report

## Public Rights-of-Way

Intersection ID: 28018	Main Street: COLONIAL_COUNTRY_LN	Cross Street: CONGRESSIONAL_CLUB_DR	Location: SW
ADA ID: D8081E328AD6	Ramp Type: PerpDiag	Initial Pass/Fail: Fail	Overall Compliance: No
Codes/Mitigation Info/Possible Solution		Field Measurements/Component Compliance	
Severity Score: 8.75

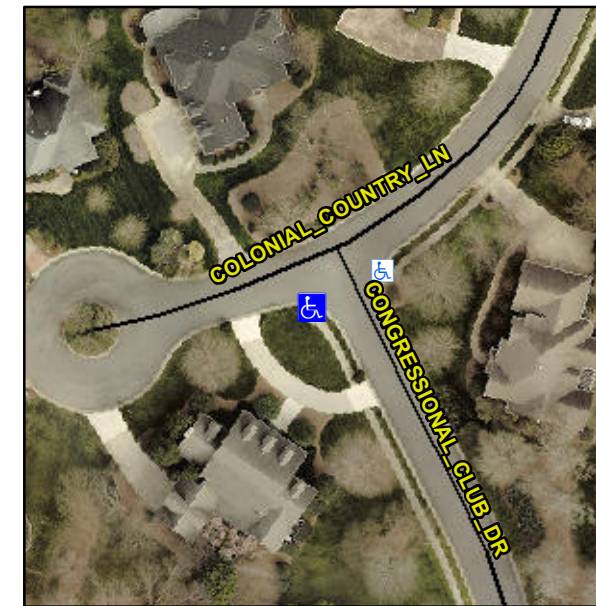
Compliance	Description	Data	Compliance	Description	Data
N/A	Ramp Length (in)	96.0	Yes	Ramp Slope (%)	5.1
No	Ramp Width (in)	47.0	Yes	Ramp XSlope (%)	1.5
N/A	Flare Type LT	N/A	N/A	Flare Type RT	N/A
N/A	Flare Slope LT (%)	N/A	N/A	Flare Slope RT (%)	N/A
N/A	Flare Traversable LT?	N/A	N/A	Flare Traversable RT?	N/A
N/A	Landing Length (in)	N/A	N/A	DWS Provided?	N/A
N/A	Landing Width (in)	N/A	N/A	DWS Contrast?	N/A
N/A	Landing Slope (%)	N/A	N/A	DWS Length (in)	N/A
N/A	Landing X Slope (%)	N/A	N/A	DWS Full Width?	N/A
N/A	Landing Curb? (Y/N)	N/A	N/A	DWS Offset (in)	N/A
N/A	Shared Landing?	N/A			
N/A	Gutter Ponding?	N/A	N/A	Gutter Slope (%)	N/A
N/A	Gutter Lip Ht (in)	N/A	N/A	Gutter X Slope (%)	N/A
N/A	Painted X Walk1?	No	N/A	Painted X Walk2?	No
	X Walk 1 Direction	To NE		X Walk 2 Direction	To N
N/A	X Walk 1 Width (in)	N/A	N/A	X Walk 2 Width (in)	N/A
	X Walk 1 Slope (%)	1.5		X Walk 2 Slope (%)	2.3
	X Walk 1 X Slope (%)	1.5		X Walk 2 X Slope (%)	1.7

N/A	Ramp inside XWalk1?	N/A	N/A	Ramp inside XWalk2?	N/A
	Road Slope (%)	0.5	N/A	Clear Space?	N/A
	Road X Slope (%)	3.7	N/A	Clear Space to XWalk (in)	N/A
N/A	Any Obstructions?	N/A	N/A	Storm Grate/Utility Hazard?	N/A
	Obstruction Type			Storm Grate/Utility Type	
		N/A			N/A
			Yes	Surface Condition? (G/P)	Good

**Remove & Replace Curb Ramp With Two New Directional Ramps or Equivalent.**

**Not Found, R304.5.1**

Total Cost: \$ 3200.00
