Access Compliance Report Public Rights-of-Way (Curb Ramps)

Intersection ID: 51721Main Street:PROVIDENCE_RD_WESTCross Street:BALLANCROFT_PYLocation:SWADA ID: D80B05141B30Ramp Type:PerpInitial Pass/Fail:FailOverall Compliance:NoSeverity Score:22.5

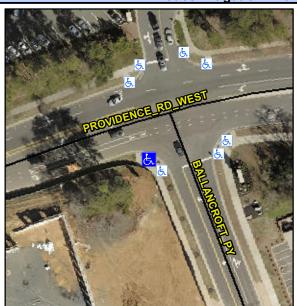
Field Measurements/Component Compliance						
Comp	liance Description	Data	Comp	liance Description	Data	
N/A	Ramp Length (in)	96.0	No	Ramp Slope (%)	9.1	
No	Ramp Width (in)	47.5	No	Ramp XSlope (%)	3.0	
N/A	Flare Type LT	N/A	N/A	Flare Type RT	N/A	
N/A	Flare Slope LT (%)	N/A	N/A	Flare Slope RT (%)	N/A	
N/A	Flare Traversable LT?	N/A	N/A	Flare Traversable RT?	N/A	
N/A	Landing Length (in)	N/A	N/A	DWS Provided?	N/A	
N/A	Landing Width (in)	N/A	N/A	DWS Contrast?	N/A	
N/A	Landing Slope (%)	N/A	N/A	DWS Length (in)	N/A	
N/A	Landing X Slope (%)	N/A	N/A	DWS Full Width?	N/A	
N/A	Landing Curb? (Y/N)	N/A	N/A	DWS Offset (in)	N/A	
N/A	Shared Landing?	N/A				
N/A	Gutter Ponding?	N/A	N/A	Gutter Slope (%)	N/A	
N/A	Gutter Lip Ht (in)	N/A	N/A	Gutter X Slope (%)	N/A	
N/A	Painted X Walk1?	No	N/A	Painted X Walk2?	N/A	
	X Walk 1 Direction	To N		X Walk 2 Direction	N/A	
N/A	X Walk 1 Width (in)	N/A	N/A	X Walk 2 Width (in)	N/A	
	X Walk 1 Slope (%)	4.1		X Walk 2 Slope (%)	N/A

X Walk 1 X Slope (%)	2.1		X Walk 2 X Slope (%)	N/A	
N/A	Ramp inside XWalk1?	N/A	N/A	Ramp inside XWalk2?	N/A	
	Road Slope (%)	N/A	N/A	Clear Space?	N/A	
	Road X Slope (%)	N/A	N/A	Clear Space to XWalk (in)	N/A	
N/A	Any Obstructions?	N/A	N/A	Storm Grate/Utility Hazard?	N/A	
	Obstruction Type			Storm Grate/Utility Type		
		N/A			N/A	
			Yes	Surface Condition? (G/P)	Good

Possible Solutions:		
Remove & Replace Entire Ramp.		
·	ı	
	N	
	1	
	1	
	1	
Surveyor Notes:	1	
N/A	1	
	1	
	1	
	N	
PROW/ADA:	N	
Not Found, R304.5.1, R304.2.2,	N	
R304.5.3	ı	
	ı

Total Cost: \$ 1850.00
