Access Compliance Report Public Rights-of-Way (Curb Ramps)

Intersection ID: 53286 Main Street: PROSPERITY_CHURCH_RD Cross Street: PROSPERITY_CHURCH_RD Location: ADA ID: D80B9EC4F9A1 Ramp Type: Perp Initial Pass/Fail: Fail **Overall Compliance: No Severity Score:** 25

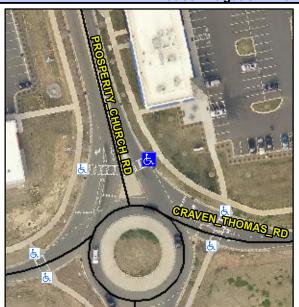
Field Measurements/Component Compliance								
Comp	liance Description	Data	Comp	liance Description	Data			
N/A	Ramp Length (in)	98.0	No	Ramp Slope (%)	16.3			
Yes	Ramp Width (in)	48.0	Yes	Ramp XSlope (%)	0.2			
N/A	Flare Type LT	N/A	N/A	Flare Type RT	N/A			
N/A	Flare Slope LT (%)	N/A	N/A	Flare Slope RT (%)	N/A			
N/A	Flare Traversable LT?	N/A	N/A	Flare Traversable RT?	N/A			
N/A	Landing Length (in)	N/A	N/A	DWS Provided?	N/A			
N/A	Landing Width (in)	N/A	N/A	DWS Contrast?	N/A			
N/A	Landing Slope (%)	N/A	N/A	DWS Length (in)	N/A			
N/A	Landing X Slope (%)	N/A	N/A	DWS Full Width?	N/A			
N/A	Landing Curb? (Y/N)	N/A	N/A	DWS Offset (in)	N/A			
N/A	Shared Landing?	N/A						
N/A	Gutter Ponding?	N/A	N/A	Gutter Slope (%)	N/A			
N/A	Gutter Lip Ht (in)	N/A	N/A	Gutter X Slope (%)	N/A			
N/A	Painted X Walk1?	Yes	N/A	Painted X Walk2?	N/A			
	X Walk 1 Direction	To W		X Walk 2 Direction	N/A			
N/A	X Walk 1 Width (in)	102.0	N/A	X Walk 2 Width (in)	N/A

X Walk 1 Slope (%)	4.4		X Walk 2 Slope (%)	N/A			
	X Walk 1 X Slope (%)	0.8		X Walk 2 X Slope (%)	N/A			
N/A	Ramp inside XWalk1?	Yes	N/A	Ramp inside XWalk2?	N/A			
	Road Slope (%)	N/A	N/A	Clear Space?	N/A			
	Road X Slope (%)	N/A	N/A	Clear Space to XWalk (in)	N/A			
N/A	Any Obstructions?	N/A	N/A	Storm Grate/Utility Hazard?	N/A			
	Obstruction Type			Storm Grate/Utility Type				
		N/A			N/A			
			Yes	Surface Condition? (G/P)	Good			
Maria de de

<u>′′ </u>	CSSIBIC COIGHOIT						
í	Possible Solutions:						
	Remove & Replace Entire Ramp.						
ı							
ı							
100	Surveyor Notes:						
3	N/A						
	PROW/ADA:						
	R304.2.2						
-

Surveyor Notes:		N/A
N/A		N/A
		N/A
		N/A
		N/A
PROW/ADA:		N/A
R304.2.2		N/A
		N/A
		N/A
		N/A
Total Cost:	\$ 1850.00	N/A
