Access Compliance Report

Public Rights-of-Way

(Curb Ramps)

Intersection ID: 14461	Main Street: E_WORTHINGTON_AV	Cross Street: LYNDHURST_AV	Location: S
ADA ID: D82A054F5987	Ramp Type: Perp	Initial Pass/Fail: Fail	Overall Compliance: No
Severity Score: 36.25			
Codes/Mitigation Info/Possible Solution		Field Measurements/Component Compliance

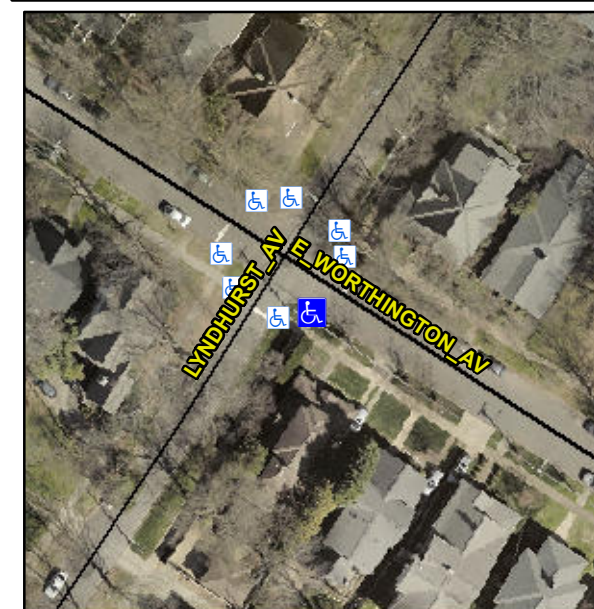
Not Found, R304.5.1, R304.5.3

Compliance	Description	Data	Compliance	Description	Data
N/A	Ramp Length (in)	55.0	Yes	Ramp Slope (%)	5.3
No	Ramp Width (in)	30.0	No	Ramp XSlope (%)	2.1
N/A	Flare Type LT	N/A	N/A	Flare Type RT	N/A
N/A	Flare Slope LT (%)	N/A	N/A	Flare Slope RT (%)	N/A
N/A	Flare Traversable LT?	N/A	N/A	Flare Traversable RT?	N/A
N/A	Landing Length (in)	N/A	N/A	DWS Provided?	N/A
N/A	Landing Width (in)	N/A	N/A	DWS Contrast?	N/A
N/A	Landing Slope (%)	N/A	N/A	DWS Length (in)	N/A
N/A	Landing X Slope (%)	N/A	N/A	DWS Full Width?	N/A
N/A	Landing Curb? (Y/N)	N/A	N/A	DWS Offset (in)	N/A
N/A	Shared Landing?	N/A			
N/A	Gutter Ponding?	N/A	N/A	Gutter Slope (%)	N/A
N/A	Gutter Lip Ht (in)	N/A	N/A	Gutter X Slope (%)	N/A
N/A	Painted X Walk1?	No	N/A	Painted X Walk2?	N/A
	X Walk 1 Direction	To NE		X Walk 2 Direction	N/A
N/A	X Walk 1 Width (in)	N/A	N/A	X Walk 2 Width (in)	N/A
	X Walk 1 Slope (%)	3.3		X Walk 2 Slope (%)	N/A
	X Walk 1 X Slope (%)	1.0		X Walk 2 X Slope (%)	N/A

N/A	Ramp inside XWalk1?	N/A	N/A	Ramp inside XWalk2?	N/A
	Road Slope (%)	N/A	N/A	Clear Space?	N/A
	Road X Slope (%)	N/A	N/A	Clear Space to XWalk (in)	N/A
N/A	Any Obstructions?	N/A	N/A	Storm Grate/Utility Hazard?	N/A
	Obstruction Type			Storm Grate/Utility Type	
		N/A			N/A
			Yes	Surface Condition? (G/P)	Good

Possible Solutions:

Remove & Replace Entire Ramp.
