Access Compliance Report Public Rights-of-Way (Curb Ramps)

Intersection ID: 30632 Main Street: PROVIDENCE_RD_WEST				ross Street: DIXIE_HILLS_DR				Location:	SW
ADA ID: D8332C5641F	D: D8332C5641F3 Ramp Type: PerpDiag			itial Pass/Fail: Fail Overall Compliance: No				o Severity Score:	25
Codes/Mitigation Info/Possible Solution				Field Measurements/Component Compliance					
		Possible Solutions:						mpliance Description	
		Remove & Replace Curb Ramp \	Nith	N/A	Ramp Length (in)	54.0	Yes	Ramp Slope (%)	Data 5.5
		Two New Directional Ramps or		Yes	Ramp Width (in)	48.5	No	Ramp XSlope (%)	10.1
And a prover it is a		Equivalent.		N/A	Flare Type LT	N/A	N/A	Flare Type RT	N/A
AND THE PARTY AGE				N/A	Flare Slope LT (%)	N/A	N/A	Flare Slope RT (%)	N/A
	3			N/A	Flare Traversable LT?	N/A	N/A	Flare Traversable RT?	N/A
THE RULE NUMBER	the states of th			N/A	Landing Length (in)	N/A	N/A	DWS Provided?	N/A
TROVIDENCE	1 Ster -	Surveyor Notes:		N/A	Landing Width (in)	N/A	N/A	DWS Contrast?	N/A

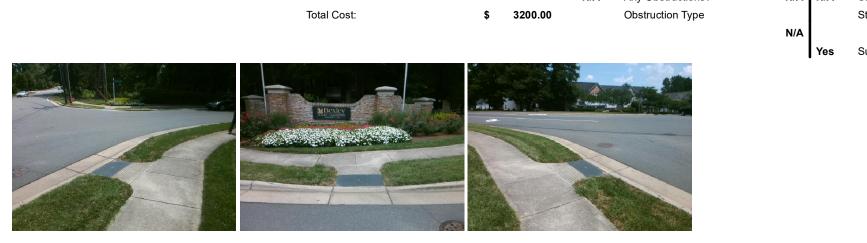
Fue				N/A	Landing Slope (%)	N/A	N/A	DWS Length (in)	N/A
		N/A		N/A	Landing X Slope (%)	N/A	N/A	DWS Full Width?	N/A
A CARDINE (PARA			N/A		N/A	N/A	DWS Offset (in)	N/A N/A	
					Landing Curb? (Y/N)		N/A	DWS Offset (III)	N/A
	E I	55011/454		N/A	Shared Landing?	N/A			N 1/A
PROW/ADA: Not Found, R304.5.3				N/A	Gutter Ponding?	N/A	N/A	Gutter Slope (%)	N/A
				N/A	Gutter Lip Ht (in)	N/A	N/A	Gutter X Slope (%)	N/A
				N/A	Painted X Walk1?	No	N/A	Painted X Walk2?	No
					X Walk 1 Direction	To E		X Walk 2 Direction	To N
				N/A	X Walk 1 Width (in)	N/A	N/A	X Walk 2 Width (in)	N/A
Street 1 Name	DIXIE HILLS DR				X Walk 1 Slope (%)	0.7		X Walk 2 Slope (%)	4.3
Stop Condition-Street 2	StopSign				X Walk 1 X Slope (%)	4.1		X Walk 2 X Slope (%)	0.6
Street 2 Name	PROVIDENCE RD WEST			N/A	Ramp inside XWalk1?	N/A	N/A	Ramp inside XWalk2?	N/A
Stop Condition-Street 1	None				Road Slope (%)	2.8	N/A	Clear Space?	N/A
					Road X Slope (%)	2.5	N/A	Clear Space to XWalk (in)	N/A

N/A	Any Obstructions?	N/A	N/A	Storm Grate/Utility Hazard?	N/A
		Total Cost: \$	3200.00		Obstruction Type			Storm Grate/Utility Type	
						N/A			N/A
