Access Compliance Report

Public Rights-of-Way

(Curb Ramps)

Intersection ID: 46708	Main Street: REA_RD	Cross Street: BLAKENEY_PROFESSIONAL_DR	Location: NW
ADA ID: D83CA1F08C3A	Ramp Type: PerpDiag	Initial Pass/Fail: Fail	Overall Compliance: No
Severity Score: 10			
Codes/Mitigation Info/Possible Solution		Field Measurements/Component Compliance

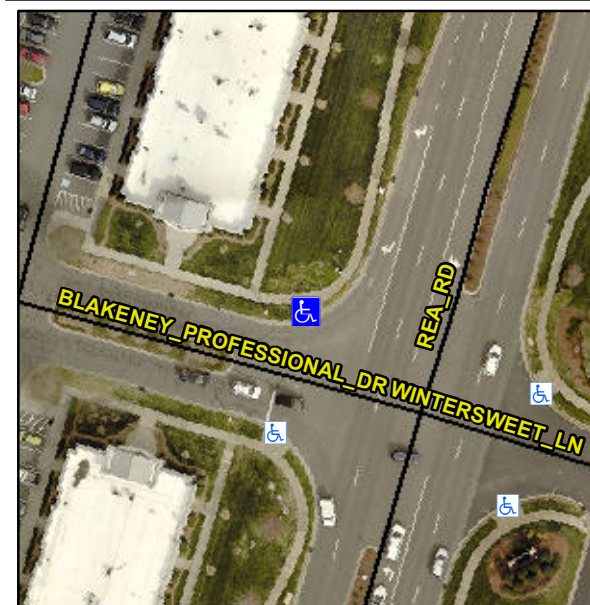
Not Found, R304.5.1, R304.5.3

Compliance	Description	Data	Compliance	Description	Data
N/A	Ramp Length (in)	87.0	Yes	Ramp Slope (%)	7.4
No	Ramp Width (in)	36.0	No	Ramp XSlope (%)	2.8
N/A	Flare Type LT	N/A	N/A	Flare Type RT	N/A
N/A	Flare Slope LT (%)	N/A	N/A	Flare Slope RT (%)	N/A
N/A	Flare Traversable LT?	N/A	N/A	Flare Traversable RT?	N/A
N/A	Landing Length (in)	N/A	N/A	DWS Provided?	N/A
N/A	Landing Width (in)	N/A	N/A	DWS Contrast?	N/A
N/A	Landing Slope (%)	N/A	N/A	DWS Length (in)	N/A
N/A	Landing X Slope (%)	N/A	N/A	DWS Full Width?	N/A
N/A	Landing Curb? (Y/N)	N/A	N/A	DWS Offset (in)	N/A
N/A	Shared Landing?	N/A			
N/A	Gutter Ponding?	N/A	N/A	Gutter Slope (%)	N/A
N/A	Gutter Lip Ht (in)	N/A	N/A	Gutter X Slope (%)	N/A
N/A	Painted X Walk1?	No	N/A	Painted X Walk2?	No
	X Walk 1 Direction	To SW		X Walk 2 Direction	To SE
N/A	X Walk 1 Width (in)	N/A	N/A	X Walk 2 Width (in)	N/A
	X Walk 1 Slope (%)	0.4		X Walk 2 Slope (%)	1.5
	X Walk 1 X Slope (%)	0.1		X Walk 2 X Slope (%)	1.8

Possible Solutions:

Remove & Replace Curb Ramp With Two New Directional Ramps or Equivalent.

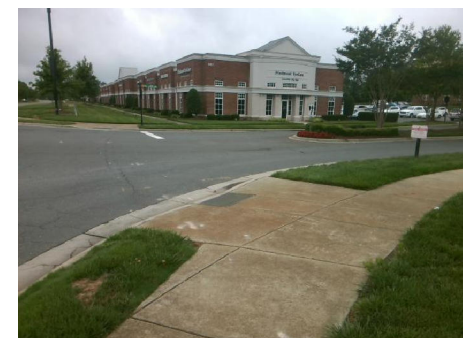
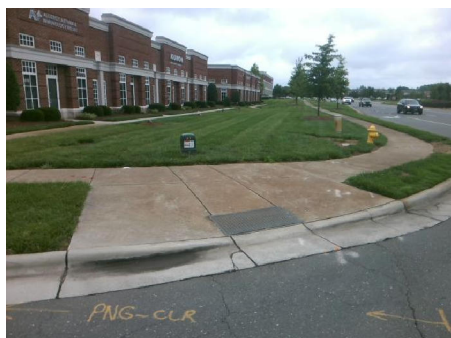
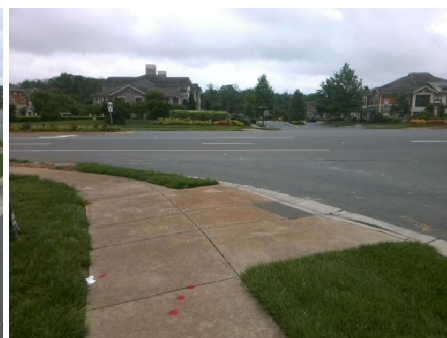
N/A	Ramp inside XWalk1?	N/A	N/A	Ramp inside XWalk2?	N/A
	Road Slope (%)	1.7	N/A	Clear Space?	N/A
	Road X Slope (%)	0.5	N/A	Clear Space to XWalk (in)	N/A
N/A	Any Obstructions?	N/A	N/A	Storm Grate/Utility Hazard?	N/A
	Obstruction Type			Storm Grate/Utility Type	
		N/A			N/A
			Yes	Surface Condition? (G/P)	Good
