# Access Compliance Report

## Public Rights-of-Way

### (Curb Ramps)

Intersection ID: 23801	Main Street: STEPHENDALE_DR	Cross Street: S_TRYON_ST	Location: SW
ADA ID: D83EE29DBD39	Ramp Type: PerpDiag	Initial Pass/Fail: Fail	Overall Compliance: No
Severity Score: 37.5			
Codes/Mitigation Info/Possible Solution		Field Measurements/Component Compliance

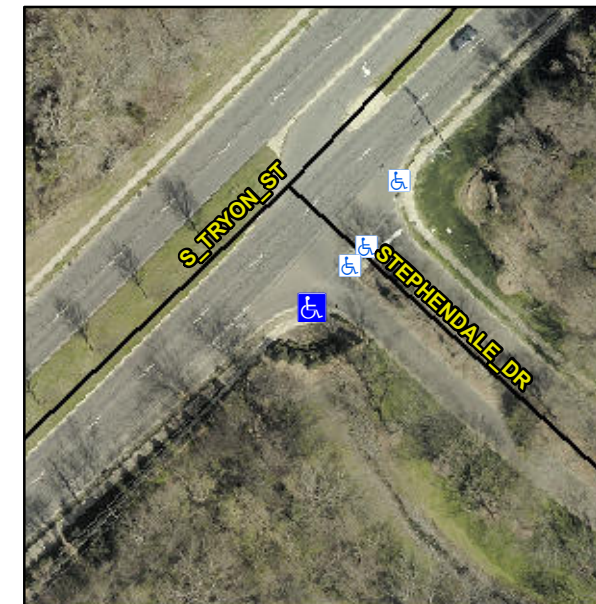
Compliance	Description	Data	Compliance	Description	Data
N/A	Ramp Length (in)	90.0	No	Ramp Slope (%)	11.4
Yes	Ramp Width (in)	51.0	No	Ramp XSlope (%)	7.0
N/A	Flare Type LT	N/A	N/A	Flare Type RT	N/A
N/A	Flare Slope LT (%)	N/A	N/A	Flare Slope RT (%)	N/A
N/A	Flare Traversable LT?	N/A	N/A	Flare Traversable RT?	N/A
N/A	Landing Length (in)	N/A	N/A	DWS Provided?	N/A
N/A	Landing Width (in)	N/A	N/A	DWS Contrast?	N/A
N/A	Landing Slope (%)	N/A	N/A	DWS Length (in)	N/A
N/A	Landing X Slope (%)	N/A	N/A	DWS Full Width?	N/A
N/A	Landing Curb? (Y/N)	N/A	N/A	DWS Offset (in)	N/A
N/A	Shared Landing?	N/A			
N/A	Gutter Ponding?	N/A	N/A	Gutter Slope (%)	N/A
N/A	Gutter Lip Ht (in)	N/A	N/A	Gutter X Slope (%)	N/A
N/A	Painted X Walk1?	No	N/A	Painted X Walk2?	No
	X Walk 1 Direction	To NE		X Walk 2 Direction	To NW
N/A	X Walk 1 Width (in)	N/A	N/A	X Walk 2 Width (in)	N/A
	X Walk 1 Slope (%)	3.6		X Walk 2 Slope (%)	9.8
	X Walk 1 X Slope (%)	7.0		X Walk 2 X Slope (%)	1.6

N/A	Ramp inside XWalk1?	N/A	N/A	Ramp inside XWalk2?	N/A
	Road Slope (%)	4.2	N/A	Clear Space?	N/A
	Road X Slope (%)	7.1	N/A	Clear Space to XWalk (in)	N/A
N/A	Any Obstructions?	N/A	N/A	Storm Grate/Utility Hazard?	N/A
	Obstruction Type			Storm Grate/Utility Type	
		N/A			N/A
			Yes	Surface Condition? (G/P)	Good

Possible Solutions:

**Remove & Replace Curb Ramp With Two New Directional Ramps or Equivalent.**

**R304.2.2, R304.5.3**

Total Cost: \$ 3200.00
