# Access Compliance Report

## Public Rights-of-Way

### (Curb Ramps)

| Intersection ID: N/A | Main Street: CLANTON_RD | Cross Street: I-77_TO_CLANTON_RD | Location: NW |

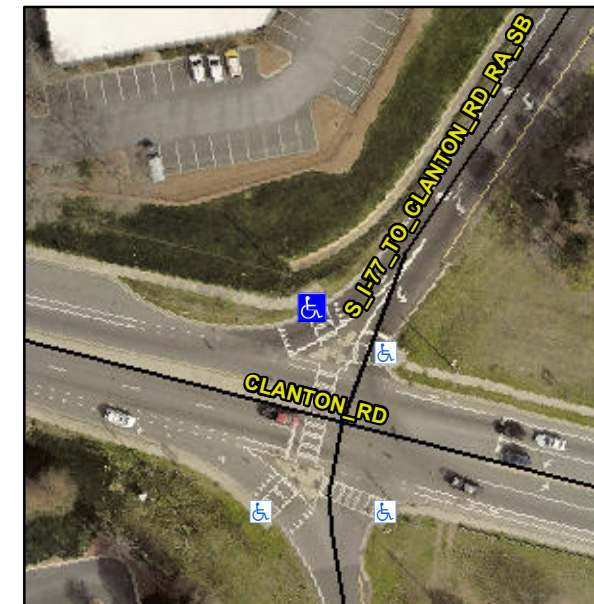
| ADA ID: D83F02D73E20 | Ramp Type: Perp | Initial Pass/Fail: Pass | Overall Compliance: No |
| | | Severity Score: 5 | |

| Compliance | Description | Data | Compliance | Description | Data |
|---|---|---|---|---|---|
| No | Landing Slope (%) | 2.6 | Yes | DWS Length (in) | 24.0 |
| N/A | Landing Curb? (Y/N) | No | No | DWS Offset (in) | 3.0 |
| Yes | Gutter Ponding? | No | No | Gutter Slope (%) | 6.1 |

**Remove & Replace Entire Ramp.  
Remove & Replace Gutter.**

**R304.2.2-Perp, R304.3.2-Para,  
R305.2, R304.5.4**

Total Cost: \$ 2600.00
