Access Compliance Report

Public Rights-of-Way

(Curb Ramps)

Intersection ID: 15195	Main Street: ALBEMARLE_RD	Cross Street: FARM_POND_LN	Location: SE
ADA ID: D8402F6D45BB	Ramp Type: Perp	Initial Pass/Fail: Fail	Overall Compliance: No
Codes/Mitigation Info/Possible Solution		Field Measurements/Component Compliance	
Severity Score: 22.5

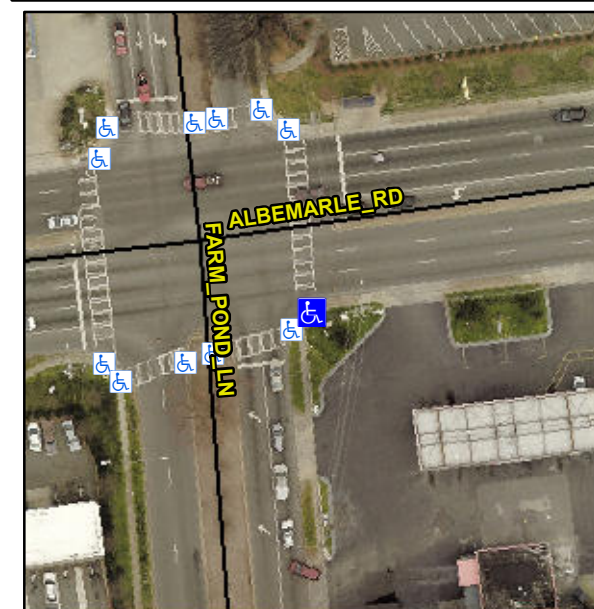
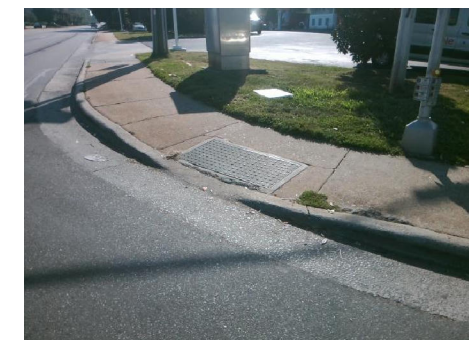
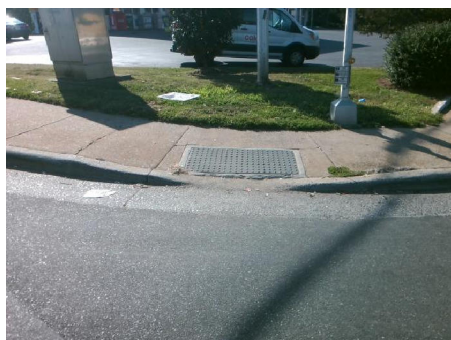
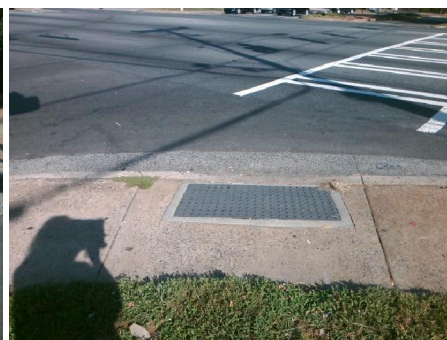
Not Found, R304.5.1, R304.2.2, R304.5.3

Compliance	Description	Data	Compliance	Description	Data
N/A	Ramp Length (in)	58.0	No	Ramp Slope (%)	9.3
No	Ramp Width (in)	41.0	No	Ramp XSlope (%)	4.4
N/A	Flare Type LT	N/A	N/A	Flare Type RT	N/A
N/A	Flare Slope LT (%)	N/A	N/A	Flare Slope RT (%)	N/A
N/A	Flare Traversable LT?	N/A	N/A	Flare Traversable RT?	N/A
N/A	Landing Length (in)	N/A	N/A	DWS Provided?	N/A
N/A	Landing Width (in)	N/A	N/A	DWS Contrast?	N/A
N/A	Landing Slope (%)	N/A	N/A	DWS Length (in)	N/A
N/A	Landing X Slope (%)	N/A	N/A	DWS Full Width?	N/A
N/A	Landing Curb? (Y/N)	N/A	N/A	DWS Offset (in)	N/A
N/A	Shared Landing?	N/A			
N/A	Gutter Ponding?	N/A	N/A	Gutter Slope (%)	N/A
N/A	Gutter Lip Ht (in)	N/A	N/A	Gutter X Slope (%)	N/A
N/A	Painted X Walk1?	Yes	N/A	Painted X Walk2?	N/A
	X Walk 1 Direction	To N		X Walk 2 Direction	N/A
N/A	X Walk 1 Width (in)	110.0	N/A	X Walk 2 Width (in)	N/A
	X Walk 1 Slope (%)	7.5		X Walk 2 Slope (%)	N/A
	X Walk 1 X Slope (%)	0.5		X Walk 2 X Slope (%)	N/A

N/A	Ramp inside XWalk1?	Yes	N/A	Ramp inside XWalk2?	N/A
	Road Slope (%)	N/A	N/A	Clear Space?	N/A
	Road X Slope (%)	N/A	N/A	Clear Space to XWalk (in)	N/A
N/A	Any Obstructions?	N/A	N/A	Storm Grate/Utility Hazard?	N/A
	Obstruction Type			Storm Grate/Utility Type	
		N/A			N/A
			Yes	Surface Condition? (G/P)	Good

Remove & Replace Entire Ramp.
