## **Access Compliance Report Public Rights-of-Way** (Curb Ramps)

Intersection ID: 5295 Main Street: HARRIS HOUSTON RD **Cross Street: UNIVERSITY\_CITY\_BV** Location: NW ADA ID: D84990669B98 Ramp Type: Perp Initial Pass/Fail: Fail **Overall Compliance: No Severity Score:** 8.75

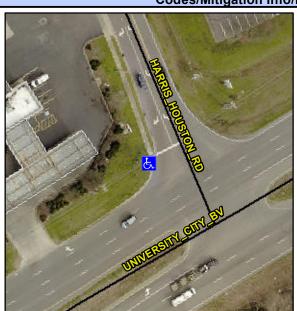
Field Measurements/Component Compliance						
Comp	liance Description	Data	Compl	iance	Description	Data
N/A	Ramp Length (in)	45.0	Yes	Ramp	Slope (%)	6.3
No	Ramp Width (in)	44.0	Yes	Ramp	XSlope (%)	0.1
N/A	Flare Type LT	N/A	N/A	Flare	Type RT	N/A
N/A	Flare Slope LT (%)	N/A	N/A	Flare	Slope RT (%)	N/A
N/A	Flare Traversable LT?	N/A	N/A	Flare	Traversable RT?	N/A
N/A	Landing Length (in)	N/A	N/A	DWS	Provided?	N/A
N/A	Landing Width (in)	N/A	N/A	DWS	Contrast?	N/A
N/A	Landing Slope (%)	N/A	N/A	DWS	Length (in)	N/A
N/A	Landing X Slope (%)	N/A	N/A	DWS	Full Width?	N/A
N/A	Landing Curb? (Y/N)	N/A	N/A	DWS	Offset (in)	N/A
N/A	Shared Landing?	N/A				
N/A	Gutter Ponding?	N/A	N/A	Gutte	r Slope (%)	N/A
N/A	Gutter Lip Ht (in)	N/A	N/A	Gutte	r X Slope (%)	N/A
N/A	Painted X Walk1?	No	N/A	Paint	ed X Walk2?	N/A
	X Walk 1 Direction	To S		X Wa	lk 2 Direction	N/A
N/A	X Walk 1 Width (in)	N/A	N/A	X Wa	lk 2 Width (in)	N/A
	X Walk 1 Slope (%)	1.2		X Wa	lk 2 Slope (%)	N/A

X Walk 1 X Slope (%)	0.5		X Wa	lk 2 X Slope (%)	N/A
N/A	Ramp inside XWalk1?	N/A	N/A	Ramp	inside XWalk2?	N/A
	Road Slope (%)	N/A	N/A	Clear	Space?	N/A
	Road X Slope (%)	N/A	N/A	Clear	Space to XWalk (in)	N/A
N/A	Any Obstructions?	N/A	N/A	Storm	n Grate/Utility Hazard?	N/A
	Obstruction Type			Storm	n Grate/Utility Type	
		N/A				N/A
			Yes	Surfa	ce Condition? (G/P)	Good

HARRIS HOUSTON RD Street 1 Name Stop Condition-Street 2 StopSign Street 2 Name N/A Stop Condition-Street 1 N/A Possible Solutions: Remove & Replace Entire Ramp. Surveyor Notes: N/A PROW/ADA: Not Found, R304.5.1
