Access Compliance Report

Public Rights-of-Way

(Curb Ramps)

Intersection ID: 31318	Main Street: DEERTON_RD	Cross Street: OLD_POTTERS_RD	Location:	E
ADA ID: D8616198F99D	Ramp Type: Perp	Initial Pass/Fail: Fail	Overall Compliance: No	Severity Score: 12.5
Codes/Mitigation Info/Possible Solution		Field Measurements/Component Compliance

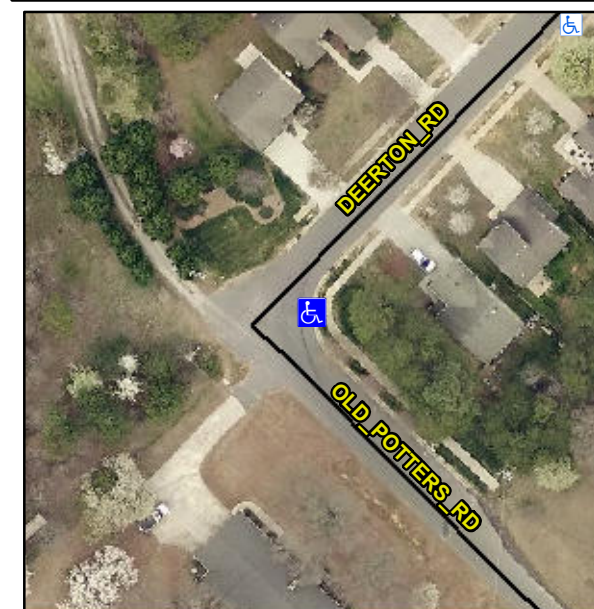
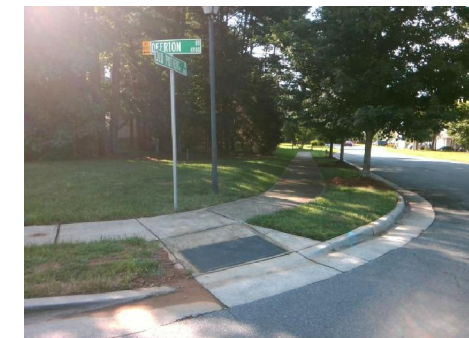
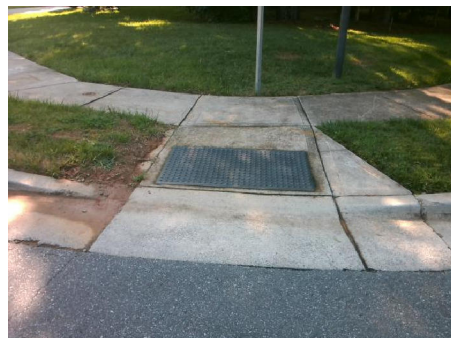
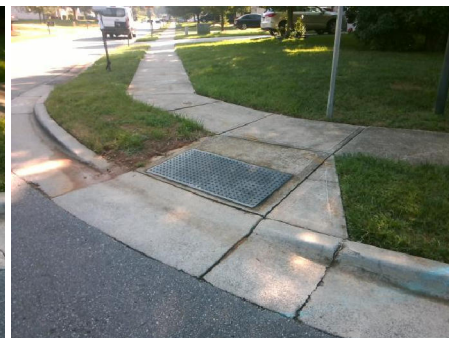
Not Found, R304.2.2

Compliance	Description	Data	Compliance	Description	Data
N/A	Ramp Length (in)	47.5	No	Ramp Slope (%)	8.6
Yes	Ramp Width (in)	54.5	Yes	Ramp XSlope (%)	2.0
N/A	Flare Type LT	N/A	N/A	Flare Type RT	N/A
N/A	Flare Slope LT (%)	N/A	N/A	Flare Slope RT (%)	N/A
N/A	Flare Traversable LT?	N/A	N/A	Flare Traversable RT?	N/A
N/A	Landing Length (in)	N/A	N/A	DWS Provided?	N/A
N/A	Landing Width (in)	N/A	N/A	DWS Contrast?	N/A
N/A	Landing Slope (%)	N/A	N/A	DWS Length (in)	N/A
N/A	Landing X Slope (%)	N/A	N/A	DWS Full Width?	N/A
N/A	Landing Curb? (Y/N)	N/A	N/A	DWS Offset (in)	N/A
N/A	Shared Landing?	N/A			
N/A	Gutter Ponding?	N/A	N/A	Gutter Slope (%)	N/A
N/A	Gutter Lip Ht (in)	N/A	N/A	Gutter X Slope (%)	N/A
N/A	Painted X Walk1?	No	N/A	Painted X Walk2?	N/A
	X Walk 1 Direction	To N		X Walk 2 Direction	N/A
N/A	X Walk 1 Width (in)	N/A	N/A	X Walk 2 Width (in)	N/A
	X Walk 1 Slope (%)	1.2		X Walk 2 Slope (%)	N/A
	X Walk 1 X Slope (%)	2.9		X Walk 2 X Slope (%)	N/A

N/A	Ramp inside XWalk1?	N/A	N/A	Ramp inside XWalk2?	N/A
	Road Slope (%)	N/A	N/A	Clear Space?	N/A
	Road X Slope (%)	N/A	N/A	Clear Space to XWalk (in)	N/A
N/A	Any Obstructions?	N/A	N/A	Storm Grate/Utility Hazard?	N/A
	Obstruction Type			Storm Grate/Utility Type	
		N/A			N/A
			Yes	Surface Condition? (G/P)	Good

Remove & Replace Entire Ramp.

Total Cost: \$ 1850.00
