Access Compliance Report

Public Rights-of-Way (Curb Ramps)

| Intersection ID: 10041074 | Main Street: WATER RIDGE PY | Cross Street: N/A | Location: SW |
| ADA ID: D861EF3D0E6F | Ramp Type: PerpDiag | Initial Pass/Fail: Fail | Overall Compliance: No |

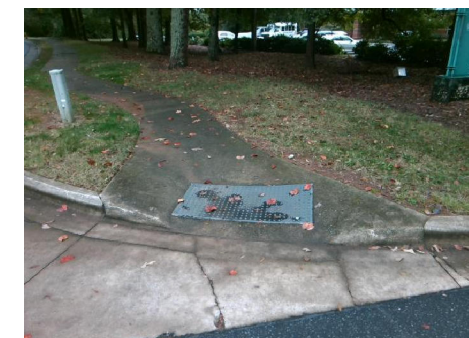
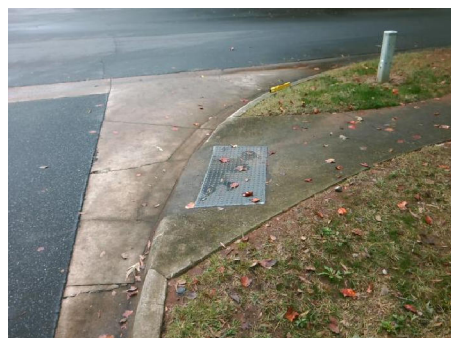
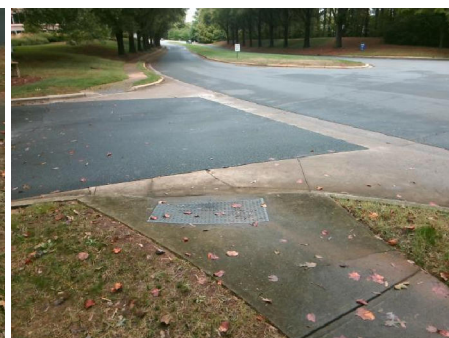
Not Found, R304.5.3

| Compliance | Description | Data | Compliance | Description | Data |
|---|---|---|---|---|---|
| Yes | Ramp Width (in) | 48.0 | No | Ramp XSlope (%) | 5.6 |

Remove & Replace Curb Ramp With Two New Directional Ramps or Equivalent.
