Access Compliance Report

Public Rights-of-Way

(Curb Ramps)

Intersection ID: 18881	Main Street: HONEGGER_DR	Cross Street: REDCOAT_DR	Location: SE
ADA ID: D863BC99ED1B	Ramp Type: Directional1	Initial Pass/Fail: Fail	Overall Compliance: No
		Severity Score: 12.5

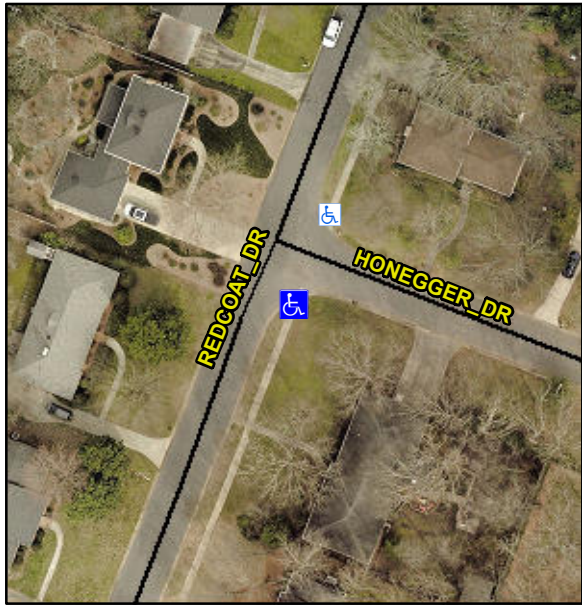
Possible Solutions:		Compliance			Description			Data	
	Remove & Replace Entire Ramp.		N/A	Ramp Length (in)	68.0	N/A	Grade Break?	N/A		
			Yes	Ramp Width (in)	57.0	N/A	Grade Break Slope (%)	0.0		
			Yes	Ramp Slope (%)	7.1	N/A	Grade Break XSlope (%)	0.0		
			No	Ramp XSlope (%)	5.5					
			N/A	Flare Type LT	N/A	N/A	Flare Type RT	N/A		
			N/A	Flare Slope LT (%)	N/A	N/A	Flare Slope RT (%)	0.0		
			N/A	Flare Traversable LT?	N/A	N/A	Flare Traversable RT?	N/A		
			N/A	Landing Length (in)	0.0	N/A	DWS Provided?	N/A		
			N/A	Landing Width (in)	0.0	N/A	DWS Contrast?	N/A		
Surveyor Notes: N/A			N/A	Landing Slope (%)	0.0	N/A	DWS Length (in)	N/A		
			N/A	Landing X Slope (%)	0.0	N/A	DWS Full Width?	N/A		
			N/A	Landing Curb? (Y/N)	N/A	N/A	DWS Offset LT (in)	N/A		
			N/A	Shared Landing?	N/A	N/A	DWS Offset RT (in)	N/A		
			N/A	Gutter Ponding?	0.0	N/A	Gutter Slope (%)	N/A

N/A	Gutter Lip Ht (in)	0.0	N/A	Gutter X Slope (%)	N/A		
			N/A	Painted X Walk1?	No		Road Slope (%)	2.4		
				X Walk 1 Direction	To NE		Road X Slope (%)	1.2		
				X Walk 1 Width (in)	N/A		Clear Space?	N/A		
				X Walk 1 Slope (%)	2.4	N/A	Clear Space to XWalk (in)	N/A		
PROW/ADA: R304.5.3				X Walk 1 X Slope (%)	1.2	N/A	Storm Grate/Utility Hazard?	N/A		
			N/A	Ramp inside XWalk1?	N/A		Storm Grate/Utility Type			
			N/A	Any Obstructions?	N/A			N/A		
				Obstruction Type		Yes	Surface Condition? (G/P)	Good		
					N/A	N/A	Curb Slope (%)	8.3		
	Total Cost:		\$	1600.00

Remove & Replace Entire Ramp.
