Access Compliance Report

Public Rights-of-Way

(Curb Ramps)

Intersection ID: 47456	Main Street: WINGED_TEAL_RD	Cross Street: HERRING_GULL_WY	Location: NW
ADA ID: D86F49493D09	Ramp Type: Perp	Initial Pass/Fail: Fail	Overall Compliance: No
Severity Score: 26.25			
Codes/Mitigation Info/Possible Solution		Field Measurements/Component Compliance

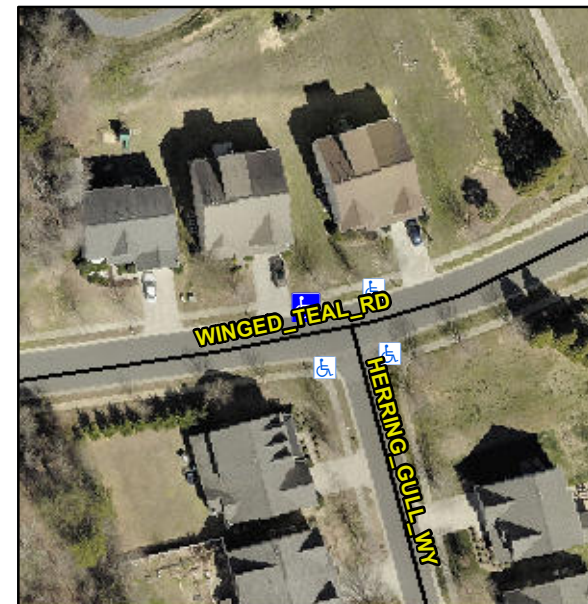
Not Found, R304.2.2, R304.5.3

Compliance	Description	Data	Compliance	Description	Data
N/A	Ramp Length (in)	47.5	No	Ramp Slope (%)	12.1
Yes	Ramp Width (in)	48.0	No	Ramp XSlope (%)	3.0
N/A	Flare Type LT	N/A	N/A	Flare Type RT	N/A
N/A	Flare Slope LT (%)	N/A	N/A	Flare Slope RT (%)	N/A
N/A	Flare Traversable LT?	N/A	N/A	Flare Traversable RT?	N/A
N/A	Landing Length (in)	N/A	N/A	DWS Provided?	N/A
N/A	Landing Width (in)	N/A	N/A	DWS Contrast?	N/A
N/A	Landing Slope (%)	N/A	N/A	DWS Length (in)	N/A
N/A	Landing X Slope (%)	N/A	N/A	DWS Full Width?	N/A
N/A	Landing Curb? (Y/N)	N/A	N/A	DWS Offset (in)	N/A
N/A	Shared Landing?	N/A			
N/A	Gutter Ponding?	N/A	N/A	Gutter Slope (%)	N/A
N/A	Gutter Lip Ht (in)	N/A	N/A	Gutter X Slope (%)	N/A
N/A	Painted X Walk1?	No	N/A	Painted X Walk2?	N/A
	X Walk 1 Direction	To S		X Walk 2 Direction	N/A
N/A	X Walk 1 Width (in)	N/A	N/A	X Walk 2 Width (in)	N/A
	X Walk 1 Slope (%)	4.1		X Walk 2 Slope (%)	N/A
	X Walk 1 X Slope (%)	2.8		X Walk 2 X Slope (%)	N/A

N/A	Ramp inside XWalk1?	N/A	N/A	Ramp inside XWalk2?	N/A
	Road Slope (%)	N/A	N/A	Clear Space?	N/A
	Road X Slope (%)	N/A	N/A	Clear Space to XWalk (in)	N/A
N/A	Any Obstructions?	N/A	N/A	Storm Grate/Utility Hazard?	N/A
	Obstruction Type			Storm Grate/Utility Type	
		N/A			N/A
			Yes	Surface Condition? (G/P)	Good

Remove & Replace Entire Ramp.
