# Access Compliance Report

## Public Rights-of-Way

### (Curb Ramps)

Intersection ID: 50615	Main Street: FAWN_LILY	Cross Street: BALSAM_BAY_RD	Location: NW
ADA ID: D874B472C247	Ramp Type: Perp	Initial Pass/Fail: Fail	Overall Compliance: No
Severity Score: 33.75			
Codes/Mitigation Info/Possible Solution		Field Measurements/Component Compliance

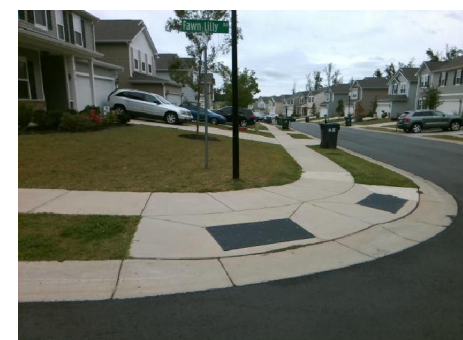
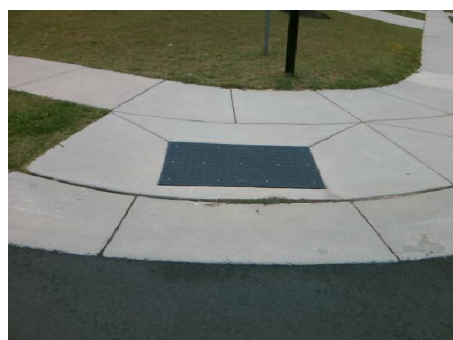
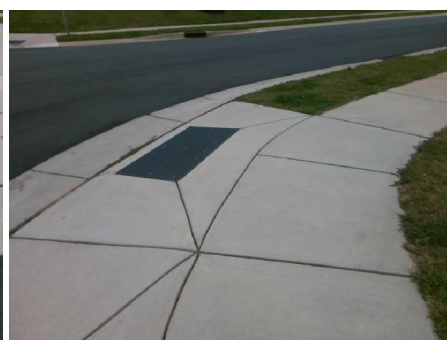
Compliance	Description	Data	Compliance	Description	Data
N/A	Ramp Length (in)	<b>49.0</b>	No	Ramp Slope (%)	<b>11.3</b>
No	Ramp Width (in)	<b>47.5</b>	No	Ramp XSlope (%)	<b>5.2</b>
N/A	Flare Type LT	<b>N/A</b>	N/A	Flare Type RT	<b>N/A</b>
N/A	Flare Slope LT (%)	<b>N/A</b>	N/A	Flare Slope RT (%)	<b>N/A</b>
N/A	Flare Traversable LT?	<b>N/A</b>	N/A	Flare Traversable RT?	<b>N/A</b>
N/A	Landing Length (in)	<b>N/A</b>	N/A	DWS Provided?	<b>N/A</b>
N/A	Landing Width (in)	<b>N/A</b>	N/A	DWS Contrast?	<b>N/A</b>
N/A	Landing Slope (%)	<b>N/A</b>	N/A	DWS Length (in)	<b>N/A</b>
N/A	Landing X Slope (%)	<b>N/A</b>	N/A	DWS Full Width?	<b>N/A</b>
N/A	Landing Curb? (Y/N)	<b>N/A</b>	N/A	DWS Offset (in)	<b>N/A</b>
N/A	Shared Landing?	<b>N/A</b>			
N/A	Gutter Ponding?	<b>N/A</b>	N/A	Gutter Slope (%)	<b>N/A</b>
N/A	Gutter Lip Ht (in)	<b>N/A</b>	N/A	Gutter X Slope (%)	<b>N/A</b>
N/A	Painted X Walk1?	<b>No</b>	N/A	Painted X Walk2?	<b>N/A</b>

X Walk 1 Direction	<b>To SE</b>		X Walk 2 Direction	<b>N/A</b>
N/A	X Walk 1 Width (in)	<b>N/A</b>	N/A	X Walk 2 Width (in)	<b>N/A</b>
	X Walk 1 Slope (%)	<b>2.3</b>		X Walk 2 Slope (%)	<b>N/A</b>
	X Walk 1 X Slope (%)	<b>3.3</b>		X Walk 2 X Slope (%)	<b>N/A</b>
N/A	Ramp inside XWalk1?	<b>N/A</b>	N/A	Ramp inside XWalk2?	<b>N/A</b>
	Road Slope (%)	<b>N/A</b>	N/A	Clear Space?	<b>N/A</b>
	Road X Slope (%)	<b>N/A</b>	N/A	Clear Space to XWalk (in)	<b>N/A</b>
N/A	Any Obstructions?	<b>N/A</b>	N/A	Storm Grate/Utility Hazard?	<b>N/A</b>
	Obstruction Type			Storm Grate/Utility Type	
		<b>N/A</b>			<b>N/A</b>
			Yes	Surface Condition? (G/P)	<b>Good</b>

**Remove & Replace Entire Ramp.**

**R304.5.1, R304.2.2, R304.5.3**
