Access Compliance Report Public Rights-of-Way (Curb Ramps)

Cross Street: PARK RD Intersection ID: 15766 Main Street: KENILWORTH AV Location: NW Initial Pass/Fail: Fail **Overall Compliance: No** ADA ID: D878CD0F550D Ramp Type: Perp **Severity Score:** 12.5

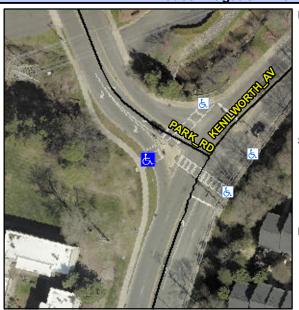
PARK RD Street 1 Name Stop Condition-Street 2 YieldSign N/A Street 2 Name Stop Condition-Street 1 N/A Possible Solutions: Compliance Description N/A Remove & Replace Entire Ramp. Yes N/A Surveyor Notes: N/A PROW/ADA: Not Found, R304.2.2
