# Access Compliance Report

## Public Rights-of-Way

### (Curb Ramps)

Intersection ID: N/A	Main Street: CONFERENCE_DR	Cross Street: OLD_POST_RD	Location: SW
ADA ID: D87A1A3BC290	Ramp Type: Directional1	Initial Pass/Fail: Fail	Overall Compliance: No
Codes/Mitigation Info/Possible Solution		Field Measurements/Component Compliance

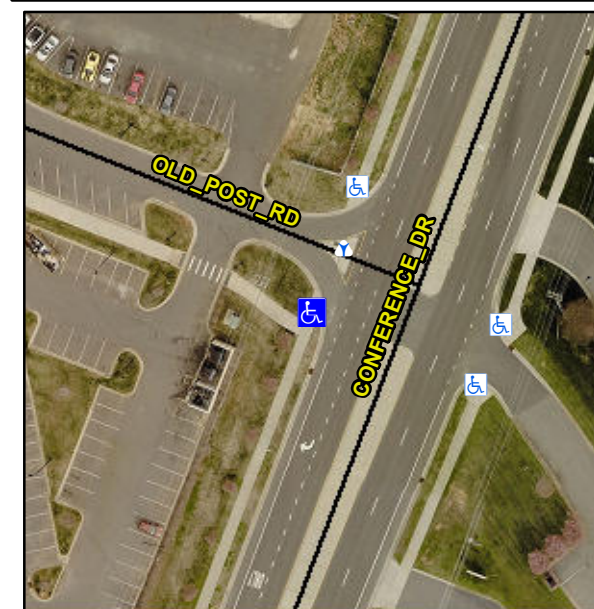
Compliance	Description	Data	Compliance	Description	Data
N/A	Ramp Length (in)	98.0	N/A	Grade Break?	N/A
Yes	Ramp Width (in)	75.0	N/A	Grade Break Slope (%)	0.0
Yes	Ramp Slope (%)	7.3	N/A	Grade Break XSlope (%)	0.0
No	Ramp XSlope (%)	3.6			
N/A	Flare Type LT	N/A	N/A	Flare Type RT	N/A
N/A	Flare Slope LT (%)	N/A	N/A	Flare Slope RT (%)	0.0
N/A	Flare Traversable LT?	N/A	N/A	Flare Traversable RT?	N/A
N/A	Landing Length (in)	0.0	N/A	DWS Provided?	N/A
N/A	Landing Width (in)	0.0	N/A	DWS Contrast?	N/A
N/A	Landing Slope (%)	0.0	N/A	DWS Length (in)	N/A
N/A	Landing X Slope (%)	0.0	N/A	DWS Full Width?	N/A
N/A	Landing Curb? (Y/N)	N/A	N/A	DWS Offset LT (in)	N/A
N/A	Shared Landing?	N/A	N/A	DWS Offset RT (in)	N/A
N/A	Gutter Ponding?	0.0	N/A	Gutter Slope (%)	N/A
N/A	Gutter Lip Ht (in)	0.0	N/A	Gutter X Slope (%)	N/A
N/A	Painted X Walk1?	No		Road Slope (%)	1.8
	X Walk 1 Direction	To NE		Road X Slope (%)	3.0
	X Walk 1 Width (in)	N/A		Clear Space?	N/A

X Walk 1 Slope (%)	1.8	N/A	Clear Space to XWalk (in)	N/A
	X Walk 1 X Slope (%)	3.0	N/A	Storm Grate/Utility Hazard?	N/A
N/A	Ramp inside XWalk1?	N/A		Storm Grate/Utility Type	
N/A	Any Obstructions?	N/A			N/A
	Obstruction Type		Yes	Surface Condition? (G/P)	Good
			N/A	Curb Slope (%)	3.7

Possible Solutions:

**Remove & Replace Entire Ramp.**

**R304.5.3**

\$ 1600.00
