# Access Compliance Report

## Public Rights-of-Way

### (Curb Ramps)

| Intersection ID: 29262 | Main Street: SPARROW_VALLEY_WY | Cross Street: POINTER_RIDGE_DR | Location: E |

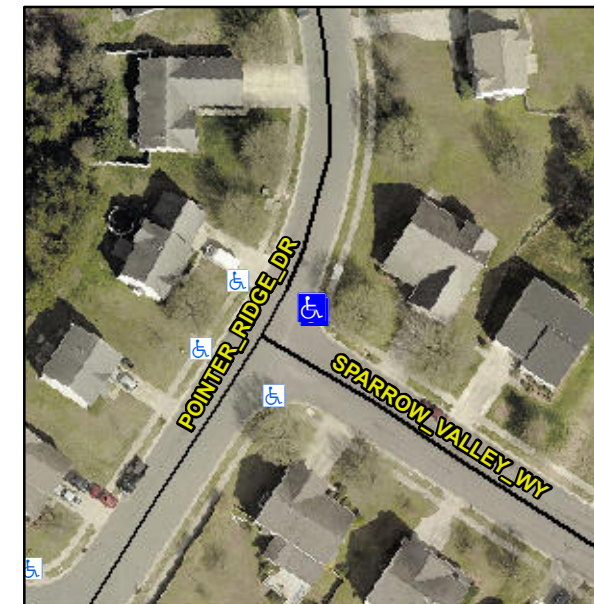
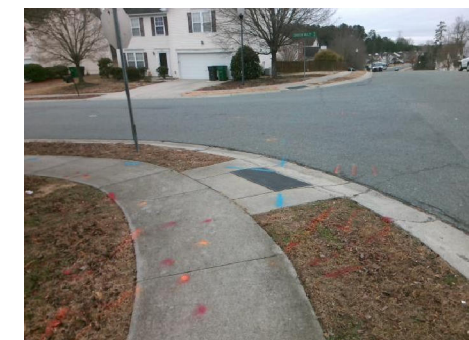
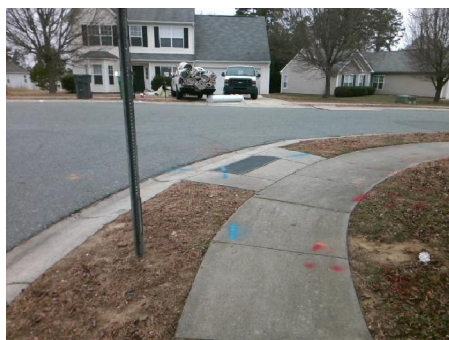
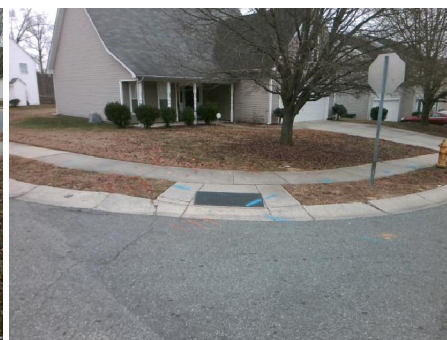
| ADA ID: D87FD945A0BE | Ramp Type: PerpDiag | Initial Pass/Fail: Fail | Overall Compliance: No |

**Not Found, R304.5.1, R304.2.2, R304.5.3**

| Compliance | Description | Data | Compliance | Description | Data |
|---|---|---|---|---|---|
| N/A | Ramp Length (in) | 51.0 | No | Ramp Slope (%) | 13.5 |
| No | Ramp Width (in) | 41.0 | No | Ramp XSlope (%) | 5.6 |

**Remove & Replace Curb Ramp With Two New Directional Ramps or Equivalent.**

Total Cost: \$ 3200.00
