# Access Compliance Report

## Public Rights-of-Way

### (Curb Ramps)

Intersection ID: 8107	Main Street: GRIERVIEW_LN	Cross Street: GRIER_RD	Location: SE
ADA ID: D8A978B87124	Ramp Type: Perp	Initial Pass/Fail: Fail	Overall Compliance: No
Severity Score: 21.25			
Codes/Mitigation Info/Possible Solution		Field Measurements/Component Compliance

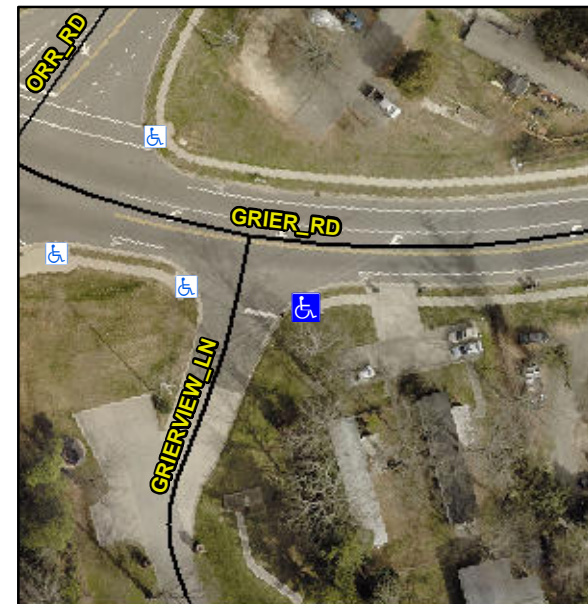
**Not Found, R304.5.1, R304.2.2**

Compliance	Description	Data	Compliance	Description	Data
N/A	Ramp Length (in)	47.5	No	Ramp Slope (%)	9.6
No	Ramp Width (in)	47.5	Yes	Ramp XSlope (%)	1.5
N/A	Flare Type LT	N/A	N/A	Flare Type RT	N/A
N/A	Flare Slope LT (%)	N/A	N/A	Flare Slope RT (%)	N/A
N/A	Flare Traversable LT?	N/A	N/A	Flare Traversable RT?	N/A
N/A	Landing Length (in)	N/A	N/A	DWS Provided?	N/A
N/A	Landing Width (in)	N/A	N/A	DWS Contrast?	N/A
N/A	Landing Slope (%)	N/A	N/A	DWS Length (in)	N/A
N/A	Landing X Slope (%)	N/A	N/A	DWS Full Width?	N/A
N/A	Landing Curb? (Y/N)	N/A	N/A	DWS Offset (in)	N/A
N/A	Shared Landing?	N/A			
N/A	Gutter Ponding?	N/A	N/A	Gutter Slope (%)	N/A
N/A	Gutter Lip Ht (in)	N/A	N/A	Gutter X Slope (%)	N/A
N/A	Painted X Walk1?	No	N/A	Painted X Walk2?	N/A
	X Walk 1 Direction	To NW		X Walk 2 Direction	N/A
N/A	X Walk 1 Width (in)	N/A	N/A	X Walk 2 Width (in)	N/A
	X Walk 1 Slope (%)	0.7		X Walk 2 Slope (%)	N/A
	X Walk 1 X Slope (%)	4.6		X Walk 2 X Slope (%)	N/A

N/A	Ramp inside XWalk1?	N/A	N/A	Ramp inside XWalk2?	N/A
	Road Slope (%)	N/A	N/A	Clear Space?	N/A
	Road X Slope (%)	N/A	N/A	Clear Space to XWalk (in)	N/A
N/A	Any Obstructions?	N/A	N/A	Storm Grate/Utility Hazard?	N/A
	Obstruction Type			Storm Grate/Utility Type	
		N/A			N/A
			Yes	Surface Condition? (G/P)	Good

**Remove & Replace Entire Ramp.**

Total Cost: \$ **1850.00**
