# Access Compliance Report

## Public Rights-of-Way

### (Curb Ramps)

Intersection ID: 15013	Main Street: E_WORTHINGTON_AV	Cross Street: EWING_AV	Location: W
ADA ID: D8B0036BEB6E	Ramp Type: Directional1	Initial Pass/Fail: Fail	Overall Compliance: No
			Severity Score: 33.75

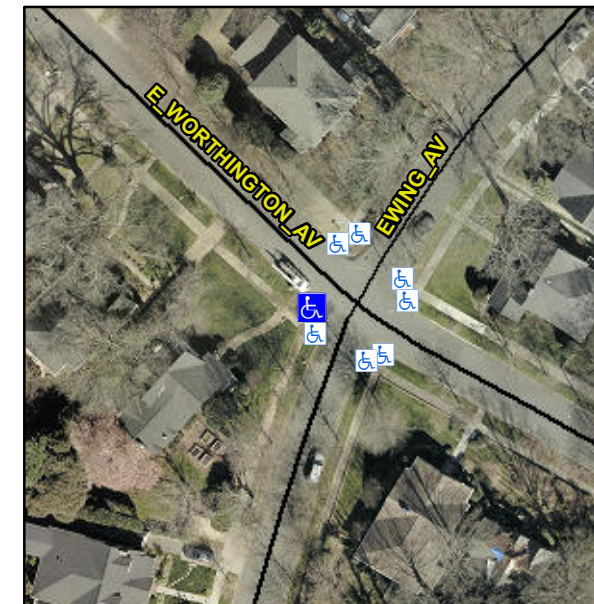
**NO CURB LINE**

**R304.5.1, R304.2.2, R304.5.3**

Compliance	Description	Data	Compliance	Description	Data
N/A	Ramp Length (in)	64.0	N/A	Grade Break?	N/A
No	Ramp Width (in)	36.0	N/A	Grade Break Slope (%)	0.0
No	Ramp Slope (%)	9.0	N/A	Grade Break XSlope (%)	0.0
No	Ramp XSlope (%)	5.1			
N/A	Flare Type LT	N/A	N/A	Flare Type RT	N/A
N/A	Flare Slope LT (%)	N/A	N/A	Flare Slope RT (%)	0.0
N/A	Flare Traversable LT?	N/A	N/A	Flare Traversable RT?	N/A
N/A	Landing Length (in)	0.0	N/A	DWS Provided?	N/A
N/A	Landing Width (in)	0.0	N/A	DWS Contrast?	N/A
N/A	Landing Slope (%)	0.0	N/A	DWS Length (in)	N/A
N/A	Landing X Slope (%)	0.0	N/A	DWS Full Width?	N/A
N/A	Landing Curb? (Y/N)	N/A	N/A	DWS Offset LT (in)	N/A
N/A	Shared Landing?	N/A	N/A	DWS Offset RT (in)	N/A
N/A	Gutter Ponding?	0.0	N/A	Gutter Slope (%)	N/A
N/A	Gutter Lip Ht (in)	0.0	N/A	Gutter X Slope (%)	N/A
N/A	Painted X Walk1?	No		Road Slope (%)	5.1
	X Walk 1 Direction	To NE		Road X Slope (%)	0.0
	X Walk 1 Width (in)	N/A		Clear Space?	N/A

X Walk 1 Slope (%)	5.1	N/A	Clear Space to XWalk (in)	N/A
	X Walk 1 X Slope (%)	0.0	N/A	Storm Grate/Utility Hazard?	N/A
N/A	Ramp inside XWalk1?	N/A		Storm Grate/Utility Type	
N/A	Any Obstructions?	N/A			N/A
	Obstruction Type		Yes	Surface Condition? (G/P)	Good
			N/A	Curb Slope (%)	7.4

**Remove & Replace Entire Ramp.**
