## Access Compliance Report Public Rights-of-Way (Curb Ramps)

Intersection ID: 4091 Main Street: DAVID\_COX\_RD Cross Street: DAVIS\_LAKE\_PY Location: SE

ADA ID: D8B9DB23347E Ramp Type: Perp Initial Pass/Fail: Fail Overall Compliance: No Severity Score: 25

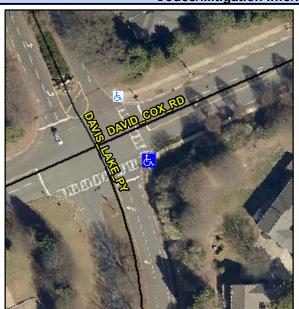
Compliance Description Data Compliance Description Data No Ramp Slope (%) N/A Ramp Length (in) 48.0 20.0 Yes Ramp XSlope (%) Yes Ramp Width (in) 48.0 1.7 N/A N/A Flare Type LT N/A Flare Type RT N/A N/A N/A N/A Flare Slope RT (%) N/A Flare Slope LT (%) N/A Flare Traversable LT? N/A N/A Flare Traversable RT? N/A N/A N/A N/A DWS Provided? N/A Landing Length (in) N/A Landing Width (in) N/A N/A **DWS Contrast?** N/A N/A N/A N/A Landing Slope (%) DWS Length (in) N/A N/A Landing X Slope (%) N/A N/A DWS Full Width? N/A N/A Landing Curb? (Y/N) N/A N/A DWS Offset (in) N/A N/A N/A Shared Landing? N/A **Gutter Ponding?** N/A N/A Gutter Slope (%) N/A N/A Gutter Lip Ht (in) N/A N/A Gutter X Slope (%) N/A N/A Painted X Walk1? Yes N/A Painted X Walk2? N/A X Walk 1 Direction To N X Walk 2 Direction N/A N/A 105.0 X Walk 2 Width (in) X Walk 1 Width (in) N/A X Walk 1 Slope (%) 0.2 X Walk 2 Slope (%) N/A X Walk 1 X Slope (%) 1.3 X Walk 2 X Slope (%) N/A N/A N/A Ramp inside XWalk2? Ramp inside XWalk1? Yes N/A Road Slope (%) N/A N/A Clear Space? N/A N/A Road X Slope (%) N/A Clear Space to XWalk (in) N/A N/A N/A Any Obstructions? N/A Storm Grate/Utility Hazard? N/A **Obstruction Type** Storm Grate/Utility Type N/A N/A Yes Surface Condition? (G/P) Good

Remove & Replace Entire Ramp.

R304.2.2
