# Access Compliance Report

## Public Rights-of-Way

### (Curb Ramps)

| Intersection ID: N/A | Main Street: SHARON_VIEW_RD | Cross Street: PARK_PHILLIPS_CT | Location: NW |

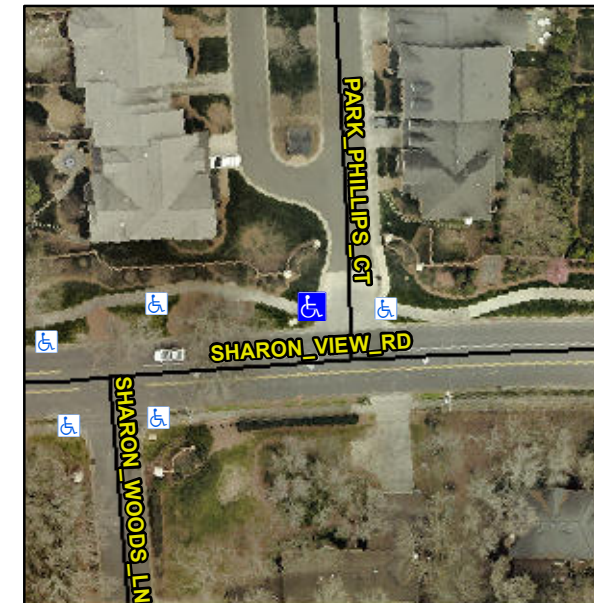
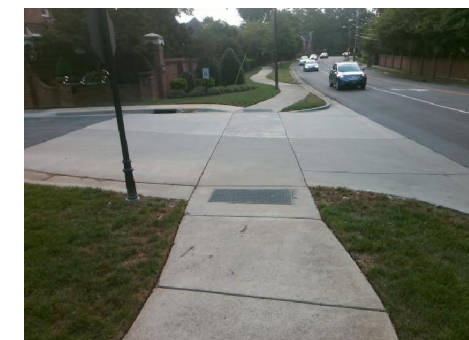
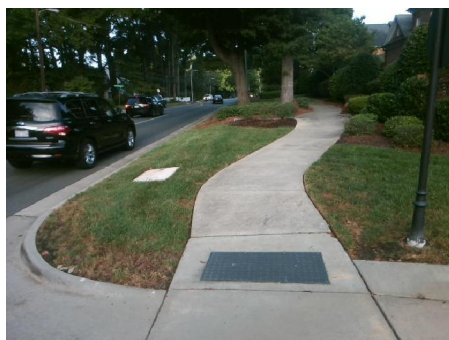
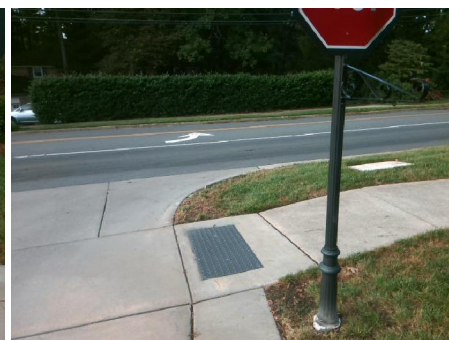
| ADA ID: D8BA9AF970AE | Ramp Type: Perp | Initial Pass/Fail: Fail | Overall Compliance: No |

**R304.5.3**

| Compliance | Description | Data | Compliance | Description | Data |
|---|---|---|---|---|---|
| Yes | Ramp Width (in) | 69.0 | No | Ramp XSlope (%) | 5.8 |

**Remove & Replace Entire Ramp.**

**\$ 1850.00**
