Access Compliance Report

Public Rights-of-Way

(Curb Ramps)

Intersection ID: N/A	Main Street: W_W_T_HARRIS_BV	Cross Street: NORTHLAKE_PLAZA_DR	Location: SW
ADA ID: D8C1E27DE645	Ramp Type: BlendTrans1	Initial Pass/Fail: Fail	Overall Compliance: No
		Severity Score: 12.5

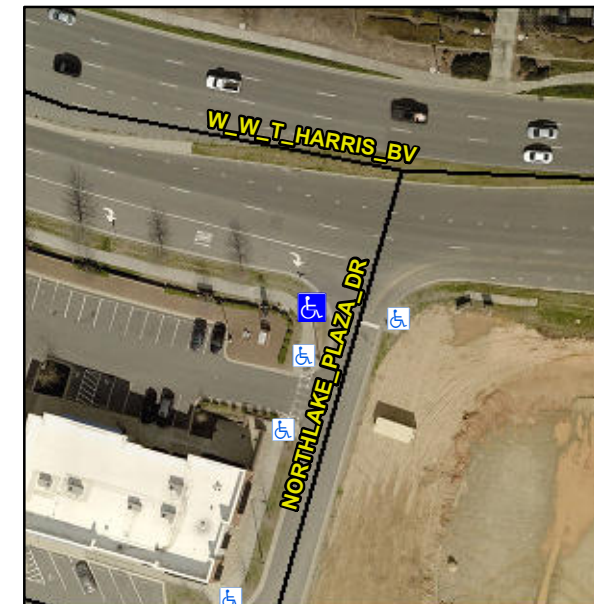
MEDIAN ACROSS W W T HARRIS BV

Not Found, R304.5.3

Compliance	Description	Data	Compliance	Description	Data
N/A	Ramp Length (in)	97.0	Yes	BlendTrans Slope (%)	3.9
Yes	Ramp Width (in)	48.0	No	BlendTrans XSlope (%)	5.6
N/A	Flare Type LT	N/A	N/A	Flare Type RT	N/A
N/A	Flare Slope LT (%)	N/A	N/A	Flare Slope RT (%)	N/A
N/A	Flare Traversable LT?	No	N/A	Flare Traversable RT?	No
N/A	Landing Length (in)	N/A	N/A	DWS Provided?	N/A
N/A	Landing Width (in)	N/A	N/A	DWS Contrast?	N/A
N/A	Landing Slope (%)	N/A	N/A	DWS Length (in)	N/A
N/A	Landing X Slope (%)	N/A	N/A	DWS Full Width?	N/A
N/A	Landing Curb? (Y/N)	N/A	N/A	DWS Offset (in)	N/A
N/A	Shared Landing?	N/A			
N/A	Gutter Ponding?	N/A	N/A	Gutter Slope (%)	N/A
N/A	Gutter Lip Ht (in)	N/A	N/A	Gutter X Slope (%)	N/A
N/A	Painted X Walk1?	No	N/A	Painted X Walk2?	No
	X Walk 1 Direction	To E		X Walk 2 Direction	To N
	X Walk 1 Width (in)	N/A		X Walk 2 Width (in)	N/A
	X Walk 1 Slope (%)	1.5		X Walk 2 Slope (%)	1.1
	X Walk 1 X Slope (%)	1.8		X Walk 2 X Slope (%)	1.3

N/A	Ramp inside XWalk1?	N/A	N/A	Ramp inside XWalk2?	N/A
	Road Slope (%)	2.3		Clear Space?	N/A
	Road X Slope (%)	1.2	N/A	Clear Space to XWalk (in)	N/A
N/A	Any Obstructions?	N/A	N/A	Storm Grate/Utility Hazard?	N/A
	Obstruction Type			Storm Grate/Utility Type	
		N/A			N/A
			Yes	Surface Condition? (G/P)	Good
			No	Curb Slope (%)	10.5

Remove & Replace Curb Ramp With Two New Directional Ramps or Equivalent.
