# Access Compliance Report

## Public Rights-of-Way

### (Curb Ramps)

Intersection ID: 12877	Main Street: E_5TH_ST	Cross Street: N_MYERS_ST	Location: W
ADA ID: D8C893A57783	Ramp Type: PerpDiag	Initial Pass/Fail: Fail	Overall Compliance: No
Severity Score: 12.5			
Codes/Mitigation Info/Possible Solution		Field Measurements/Component Compliance

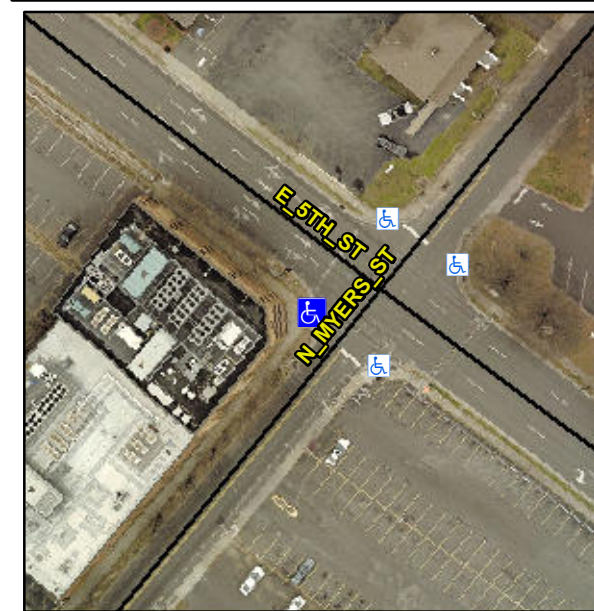
**Not Found, R304.5.3**

Compliance	Description	Data	Compliance	Description	Data
N/A	Ramp Length (in)	63.0	Yes	Ramp Slope (%)	6.1
Yes	Ramp Width (in)	48.0	No	Ramp XSlope (%)	6.7
N/A	Flare Type LT	N/A	N/A	Flare Type RT	N/A
N/A	Flare Slope LT (%)	N/A	N/A	Flare Slope RT (%)	N/A
N/A	Flare Traversable LT?	N/A	N/A	Flare Traversable RT?	N/A
N/A	Landing Length (in)	N/A	N/A	DWS Provided?	N/A
N/A	Landing Width (in)	N/A	N/A	DWS Contrast?	N/A
N/A	Landing Slope (%)	N/A	N/A	DWS Length (in)	N/A
N/A	Landing X Slope (%)	N/A	N/A	DWS Full Width?	N/A
N/A	Landing Curb? (Y/N)	N/A	N/A	DWS Offset (in)	N/A
N/A	Shared Landing?	N/A			
N/A	Gutter Ponding?	N/A	N/A	Gutter Slope (%)	N/A
N/A	Gutter Lip Ht (in)	N/A	N/A	Gutter X Slope (%)	N/A
N/A	Painted X Walk1?	No	N/A	Painted X Walk2?	No
	X Walk 1 Direction	To SE		X Walk 2 Direction	To NE
N/A	X Walk 1 Width (in)	N/A	N/A	X Walk 2 Width (in)	N/A
	X Walk 1 Slope (%)	0.2		X Walk 2 Slope (%)	3.0
	X Walk 1 X Slope (%)	1.1		X Walk 2 X Slope (%)	4.0

N/A	Ramp inside XWalk1?	N/A	N/A	Ramp inside XWalk2?	N/A
	Road Slope (%)	2.8	N/A	Clear Space?	N/A
	Road X Slope (%)	4.1	N/A	Clear Space to XWalk (in)	N/A
N/A	Any Obstructions?	N/A	N/A	Storm Grate/Utility Hazard?	N/A
	Obstruction Type			Storm Grate/Utility Type	
		N/A			N/A
		Yes		Surface Condition? (G/P)	Good

**Remove & Replace Curb Ramp With Two New Directional Ramps or Equivalent.**

Total Cost: \$ 3200.00
