Access Compliance Report

Public Rights-of-Way

(Curb Ramps)

| Intersection ID: N/A | Main Street: CITY_PARK_DR | Cross Street: TYVOLA_RD | Location: E |

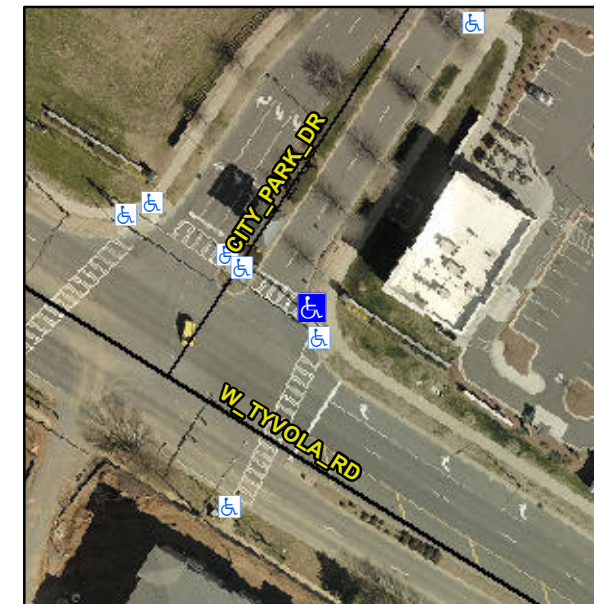
| ADA ID: D8C9816FD650 | Ramp Type: Perp | Initial Pass/Fail: Fail | Overall Compliance: No |

Not Found, R304.5.3

| Compliance | Description | Data | Compliance | Description | Data |
|---|---|---|---|---|---|
| N/A | Ramp Length (in) | 96.0 | Yes | Ramp Slope (%) | 7.2 |
| Yes | Ramp Width (in) | 48.0 | No | Ramp XSlope (%) | 5.1 |

Remove & Replace Entire Ramp.
