# Access Compliance Report

## Public Rights-of-Way

### (Curb Ramps)

| Intersection ID: 10035937 | Main Street: RICHLAND_DR | Cross Street: N/A | Location: E |

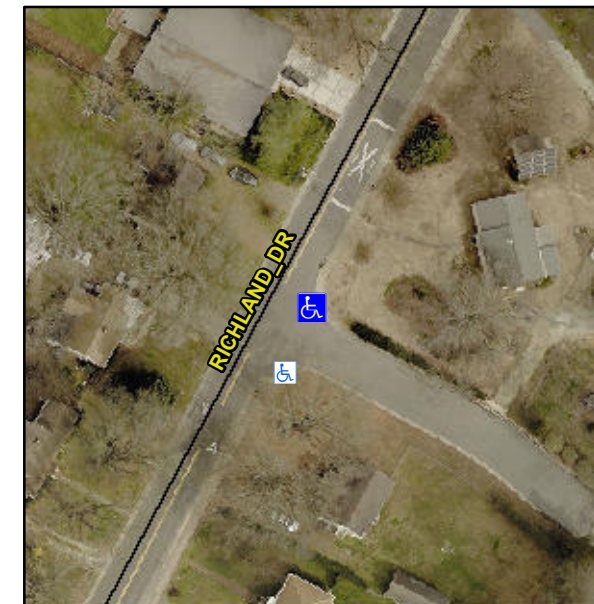
**Not Found, R304.2.2, R304.5.3**

| Compliance | Description | Data | Compliance | Description | Data |
|---|---|---|---|---|---|
| N/A | Ramp Length (in) | 51.0 | No | Ramp Slope (%) | 12.2 |
| Yes | Ramp Width (in) | 48.0 | No | Ramp XSlope (%) | 3.9 |

**Remove & Replace Curb Ramp With Two New Directional Ramps or Equivalent.**
