# Access Compliance Report

## Public Rights-of-Way

### (Curb Ramps)

Intersection ID: 15174	Main Street: DILWORTH_RD_WEST	Cross Street: IDEAL_WY	Location: NW
ADA ID: D8DE64C3E4FD	Ramp Type: Directional1	Initial Pass/Fail: Fail	Overall Compliance: No
Severity Score: 1.25			
Codes/Mitigation Info/Possible Solution		Field Measurements/Component Compliance

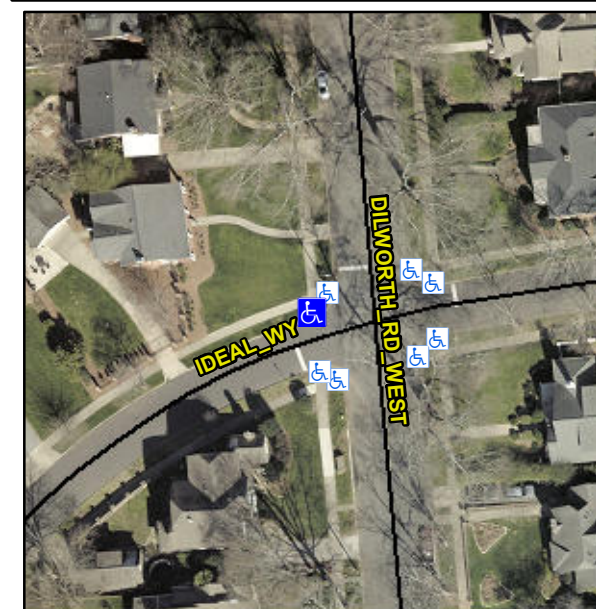
Compliance	Description	Data	Compliance	Description	Data
N/A	Ramp Length (in)	71.0	N/A	Grade Break?	N/A
Yes	Ramp Width (in)	55.0	N/A	Grade Break Slope (%)	0.0
Yes	Ramp Slope (%)	5.2	N/A	Grade Break XSlope (%)	0.0
No	Ramp XSlope (%)	2.1			
N/A	Flare Type LT	N/A	N/A	Flare Type RT	N/A
N/A	Flare Slope LT (%)	N/A	N/A	Flare Slope RT (%)	0.0
N/A	Flare Traversable LT?	N/A	N/A	Flare Traversable RT?	N/A
N/A	Landing Length (in)	0.0	N/A	DWS Provided?	N/A
N/A	Landing Width (in)	0.0	N/A	DWS Contrast?	N/A
N/A	Landing Slope (%)	0.0	N/A	DWS Length (in)	N/A
N/A	Landing X Slope (%)	0.0	N/A	DWS Full Width?	N/A
N/A	Landing Curb? (Y/N)	N/A	N/A	DWS Offset LT (in)	N/A
N/A	Shared Landing?	N/A	N/A	DWS Offset RT (in)	N/A
N/A	Gutter Ponding?	0.0	N/A	Gutter Slope (%)	N/A
N/A	Gutter Lip Ht (in)	1.0	N/A	Gutter X Slope (%)	N/A
N/A	Painted X Walk1?	No		Road Slope (%)	5.3
	X Walk 1 Direction	To SE		Road X Slope (%)	3.2
	X Walk 1 Width (in)	N/A		Clear Space?	N/A

X Walk 1 Slope (%)	5.3	N/A	Clear Space to XWalk (in)	N/A
	X Walk 1 X Slope (%)	3.2	N/A	Storm Grate/Utility Hazard?	N/A
N/A	Ramp inside XWalk1?	N/A		Storm Grate/Utility Type	
N/A	Any Obstructions?	N/A			N/A
	Obstruction Type		Yes	Surface Condition? (G/P)	Good
			N/A	Curb Slope (%)	13.2

**Remove & Replace Entire Ramp.**

**R304.5.3**
