Access Compliance Report Public Rights-of-Way (Curb Ramps)

Intersection ID: 11613 Main Street: W_7TH_ST Cross Street: N_GRAHAM_ST Location: W

ADA ID: D8EE908AA950 Ramp Type: BlendTrans1 Initial Pass/Fail: Fail Overall Compliance: No Severity Score: 12.5

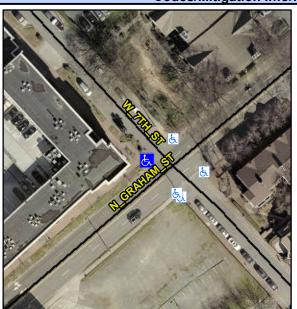
Field Measurements/Component Compliance					
Compliance Description		Data	Compliance Description		Data
N/A	Ramp Length (in)	27.5	Yes	BlendTrans Slope (%)	0.6
Yes	Ramp Width (in)	48.0	No	BlendTrans XSlope (%)	6.7
N/A	Flare Type LT	N/A	N/A	Flare Type RT	N/A
N/A	Flare Slope LT (%)	N/A	N/A	Flare Slope RT (%)	N/A
N/A	Flare Traversable LT?	N/A	N/A	Flare Traversable RT?	N/A
N/A	Landing Length (in)	N/A	N/A	DWS Provided?	N/A
N/A	Landing Width (in)	N/A	N/A	DWS Contrast?	N/A
N/A	Landing Slope (%)	N/A	N/A	DWS Length (in)	N/A
N/A	Landing X Slope (%)	N/A	N/A	DWS Full Width?	N/A
N/A	Landing Curb? (Y/N)	N/A	N/A	DWS Offset (in)	N/A
N/A	Shared Landing?	N/A			
N/A	Gutter Ponding?	N/A	N/A	Gutter Slope (%)	N/A
N/A	Gutter Lip Ht (in)	N/A	N/A	Gutter X Slope (%)	N/A
N/A	Painted X Walk1?	No	N/A	Painted X Walk2?	No
	X Walk 1 Direction	To SE		X Walk 2 Direction	To NE
	X Walk 1 Width (in)	N/A		X Walk 2 Width (in)	N/A
	X Walk 1 Slope (%)	0.2		X Walk 2 Slope (%)	6.6

X Walk 1 X Slope (%)	5.4		X Walk 2 X Slope (%)	2.3
N/A	Ramp inside XWalk1?	N/A	N/A	Ramp inside XWalk2?	N/A
	Road Slope (%)	4.6		Clear Space?	N/A
	Road X Slope (%)	3.8	N/A	Clear Space to XWalk (in)	N/A
N/A	Any Obstructions?	N/A	N/A	Storm Grate/Utility Hazard?	N/A
	Obstruction Type			Storm Grate/Utility Type	
		N/A	l		N/A
			Yes	Surface Condition? (G/P)	Good
To the last	Construction of the last of th		N/A	Curb Slope (%)	0.9

Possible Solutions:

Remove & Replace Curb Ramp With
Two New Directional Ramps or
Equivalent.

PROW/ADA:
R304.5.3
