Access Compliance Report

Public Rights-of-Way

(Curb Ramps)

Intersection ID: 30465	Main Street: PLANTERS_ROW_DR	Cross Street: GOLDEN_VIEW_DR	Location: NE
ADA ID: D8EF877786A4	Ramp Type: Directional1	Initial Pass/Fail: Fail	Overall Compliance: No
		Severity Score: 25

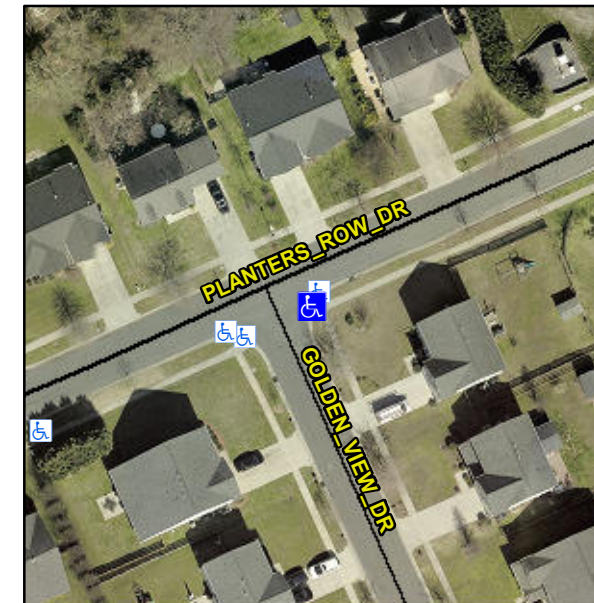
R304.5.3

Compliance	Description	Data	Compliance	Description	Data
N/A	Ramp Length (in)	48.0	N/A	Grade Break?	N/A
Yes	Ramp Width (in)	57.0	N/A	Grade Break Slope (%)	0.0
Yes	Ramp Slope (%)	4.7	N/A	Grade Break XSlope (%)	0.0
No	Ramp XSlope (%)	8.9			
N/A	Flare Type LT	N/A	N/A	Flare Type RT	N/A
N/A	Flare Slope LT (%)	N/A	N/A	Flare Slope RT (%)	0.0
N/A	Flare Traversable LT?	N/A	N/A	Flare Traversable RT?	N/A
N/A	Landing Length (in)	0.0	N/A	DWS Provided?	N/A
N/A	Landing Width (in)	0.0	N/A	DWS Contrast?	N/A
N/A	Landing Slope (%)	0.0	N/A	DWS Length (in)	N/A
N/A	Landing X Slope (%)	0.0	N/A	DWS Full Width?	N/A
N/A	Landing Curb? (Y/N)	N/A	N/A	DWS Offset LT (in)	N/A
N/A	Shared Landing?	N/A	N/A	DWS Offset RT (in)	N/A
N/A	Gutter Ponding?	0.0	N/A	Gutter Slope (%)	N/A
N/A	Gutter Lip Ht (in)	0.0	N/A	Gutter X Slope (%)	N/A
N/A	Painted X Walk1?	No		Road Slope (%)	3.2
	X Walk 1 Direction	To SW		Road X Slope (%)	2.4
	X Walk 1 Width (in)	N/A		Clear Space?	N/A

X Walk 1 Slope (%)	3.2	N/A	Clear Space to XWalk (in)	N/A
	X Walk 1 X Slope (%)	2.4	N/A	Storm Grate/Utility Hazard?	N/A
N/A	Ramp inside XWalk1?	N/A		Storm Grate/Utility Type	
N/A	Any Obstructions?	N/A			N/A
	Obstruction Type		Yes	Surface Condition? (G/P)	Good
			N/A	Curb Slope (%)	7.7

Remove & Replace Entire Ramp.
